*The Horizontal Band Saw Incident at  
the B&W NOG-L Facility*

Larry L. Wetzel, P. E.  
*Advisory Engineer*

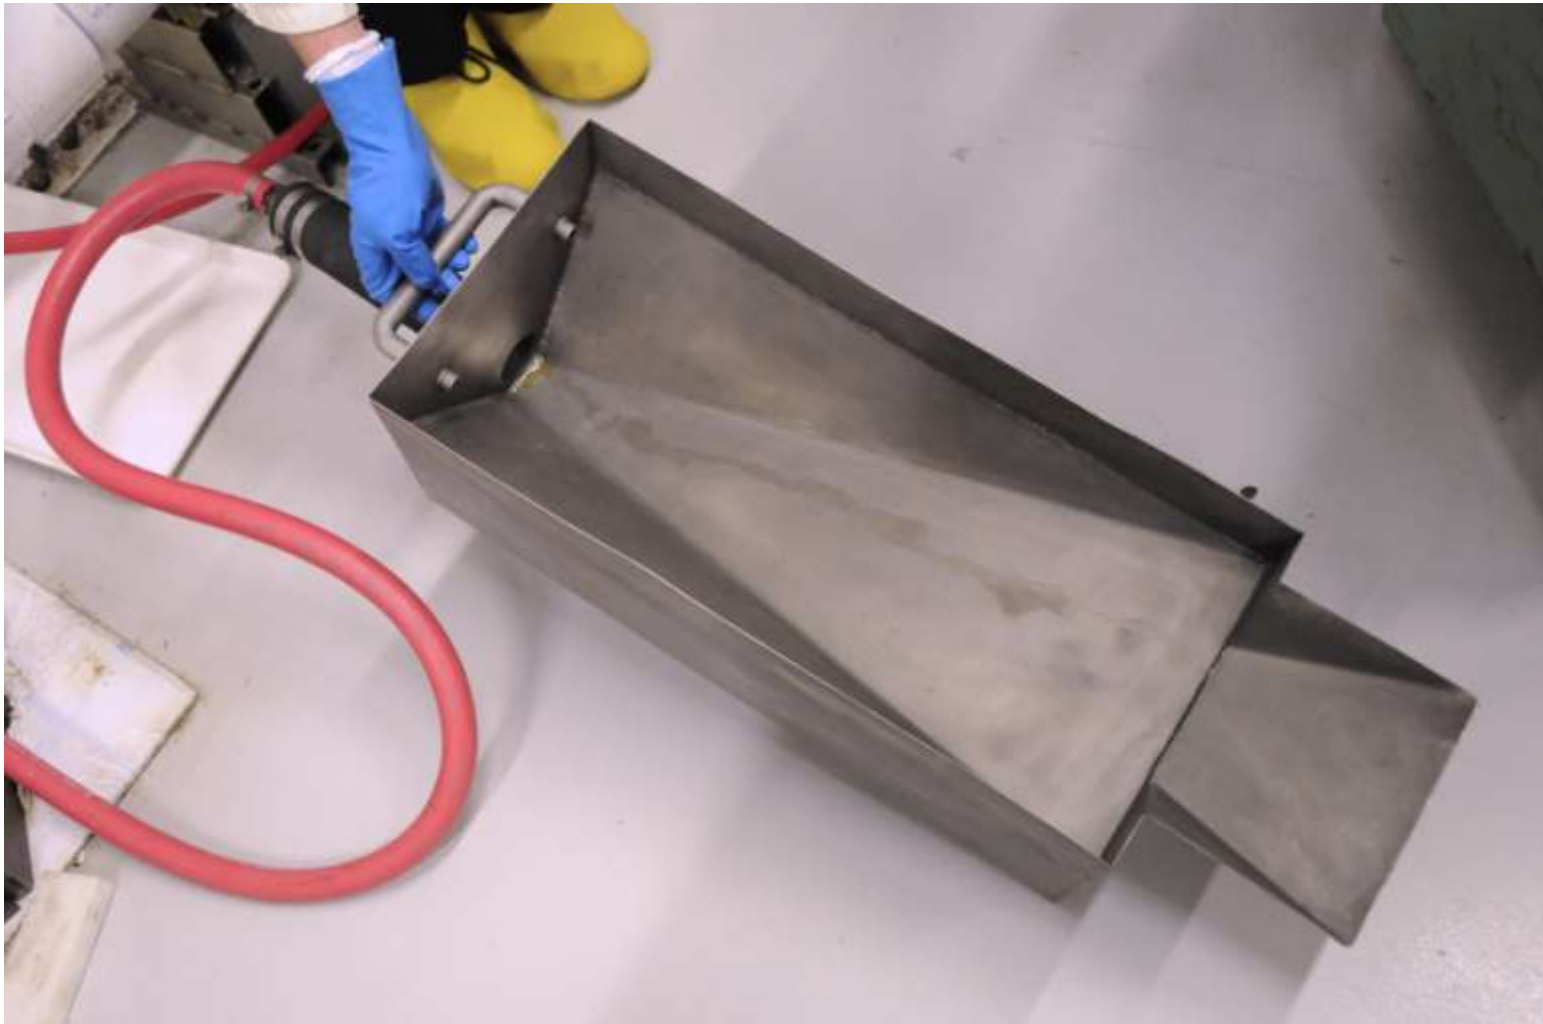
# Diverter Tray

- Diverter tray design not evaluated.
  - Tray did not completely divert liquid flow.
  - Tray could vibrate out of position during operation.
- NCS Requirement not adequately verified.
  - Disabling of the sump not adequately verified.

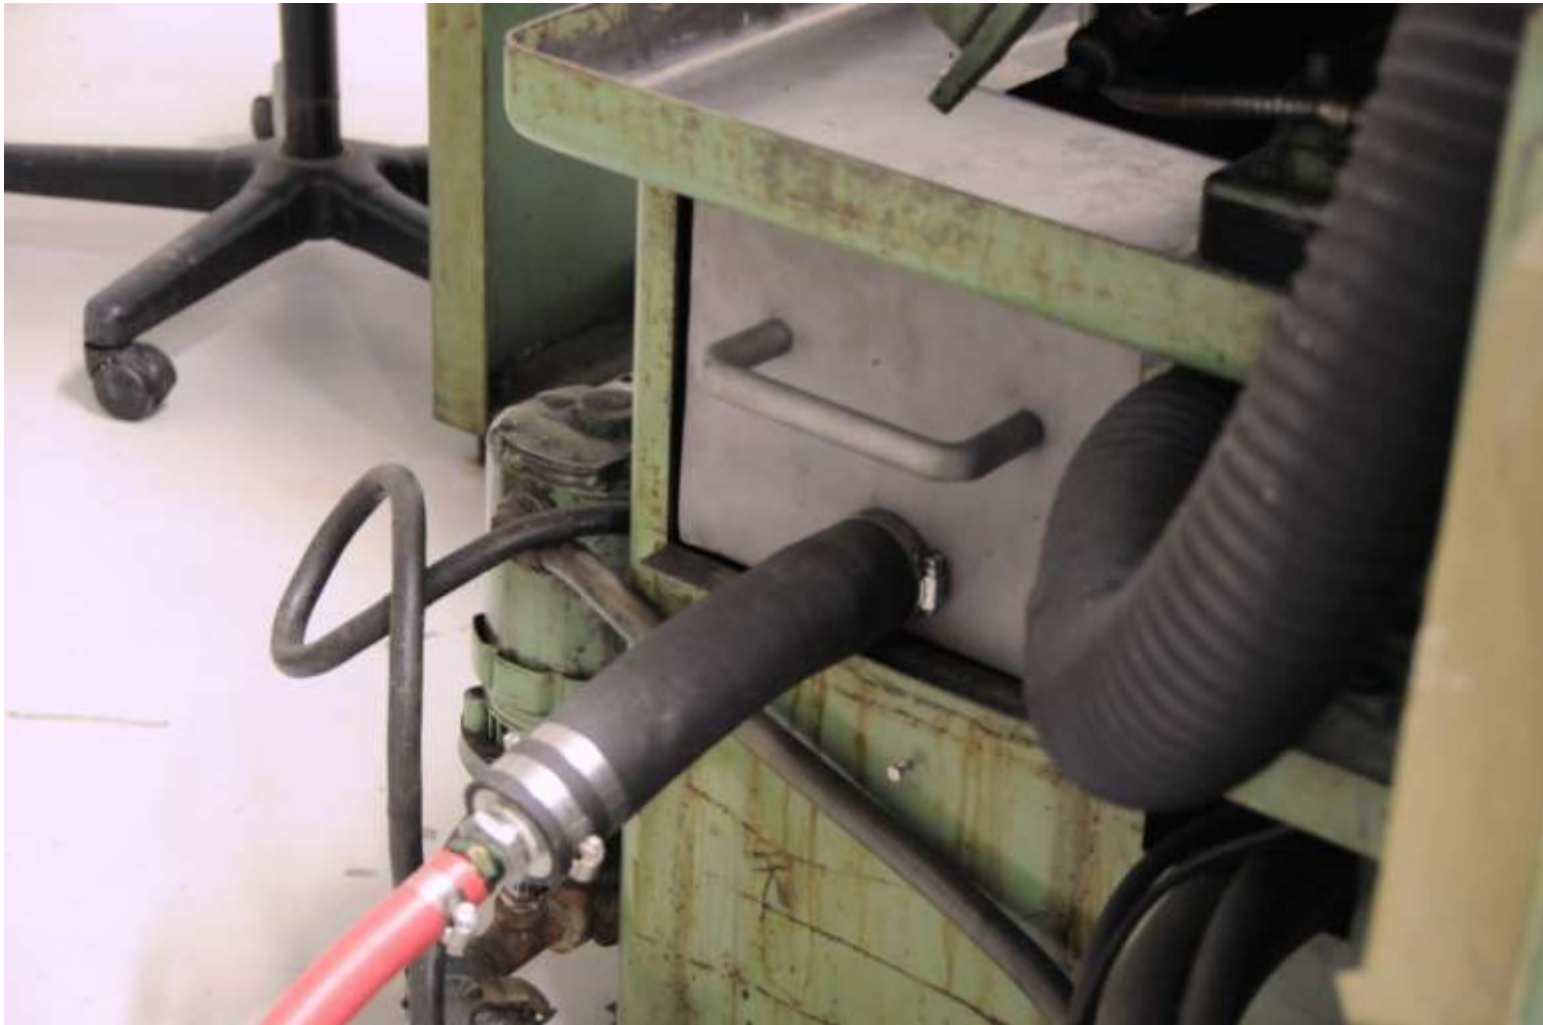
# Diverter Tray Installed

- Equipment released on May 12, 2004.
- Release stated: NCS verified that the machine was connected to the new coolant system.
  - No check was made to verify that the old sump was unusable.
  - The sump inlets and outlets were plugged but the sump was never sealed off.
- Operators were not aware there was a sump in the saw.

- The operator removed the diverter tray.
  - Original sump was full of cutting fluid
  - Leaking screw hole was near the top of the sump
- The area was secured and cordoned off.
- Safety basis was reviewed and determined that no controls were in place to ensure safe operation.

- Equipment Modification
  - Equipment re-evaluated and modified under current change management procedures.
  - Sump was removed.
- NCS release
  - Enhances instructions on verification of requirements.
  - Implemented requirement that two NCS engineers perform verifications.
- Performed extent-of-cause and condition reviews.
