# Criticality Safety and Non Destructive Assay ‘A K-25 Love Story?’

**Roger W. Bartholomay**

**Dr. Brandon P. Rasmussen**

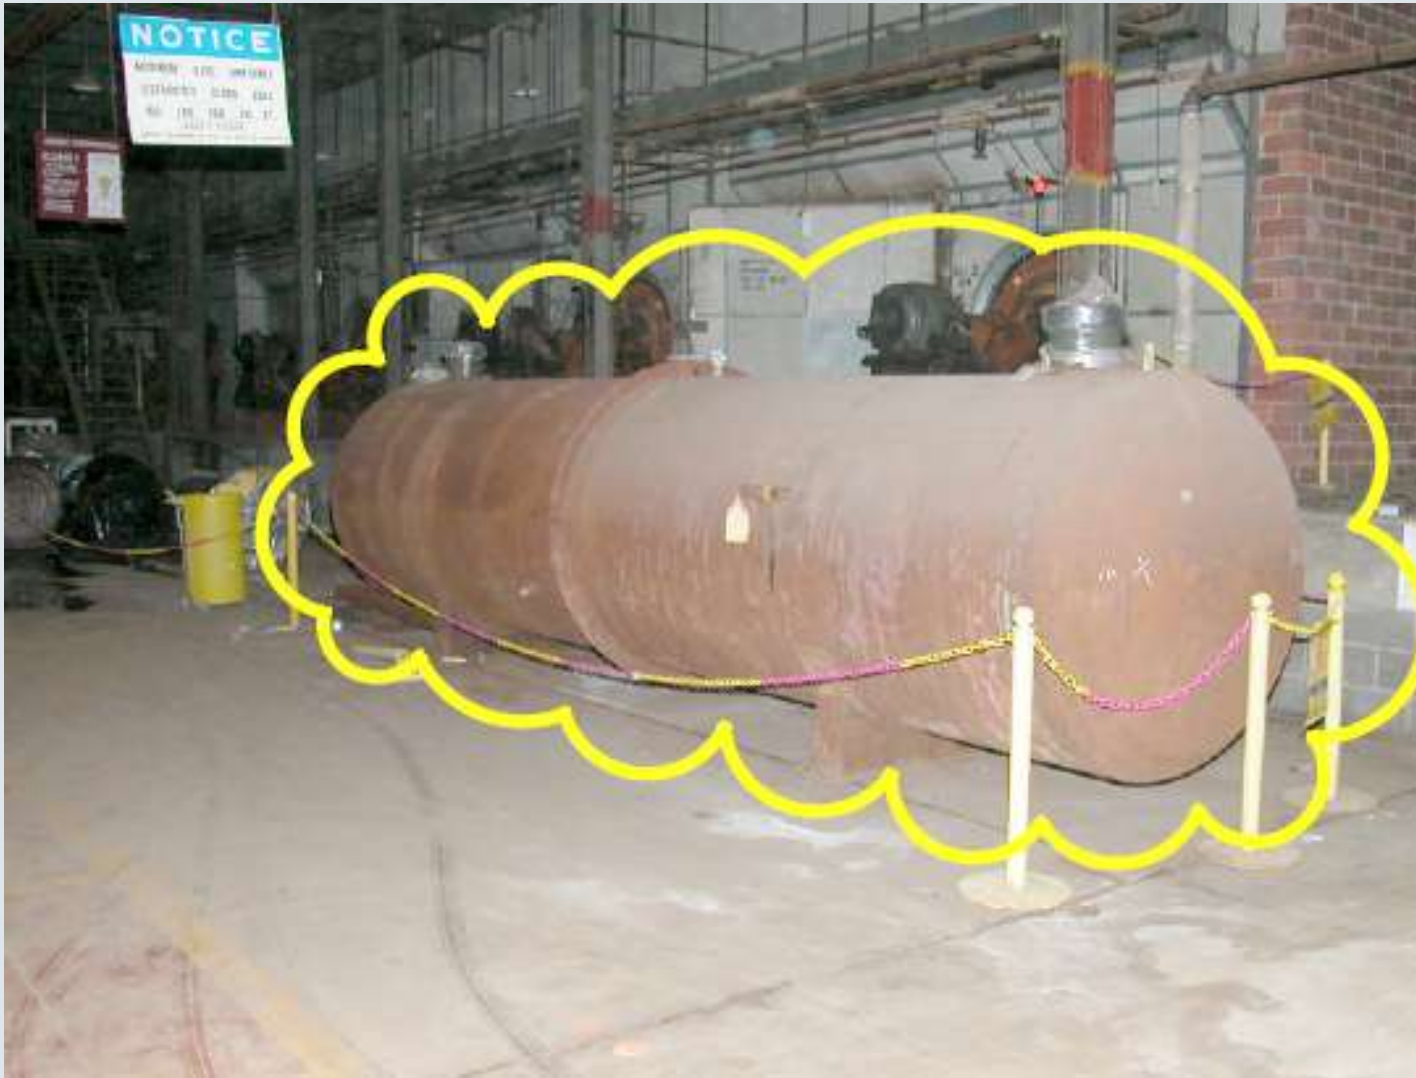
# Surge Tanks

- ★ Between 4 and 8 foot diameter tanks
- ★ 15 to 26 feet long
- ★ 1980s neutron and gamma based NDA results indicated 17 tanks ranging from ~350 g to ~9,000 g  $^{235}\text{U}$
- ★ Most of them were dry, before and during planned movement, but 3 smaller diameter tanks contained Millers Fluorinated Lubricant

- ☆ **For smaller diameter surge tanks the contemporary NDA results at  $+2\sigma$  averaged over 1000 g less than historical 1980s NDA results**
- ☆ **For the bounding large diameter surge tank, the contemporary NDA allowed the normal condition  $^{235}\text{U}$  mass to drop by 2300 g**

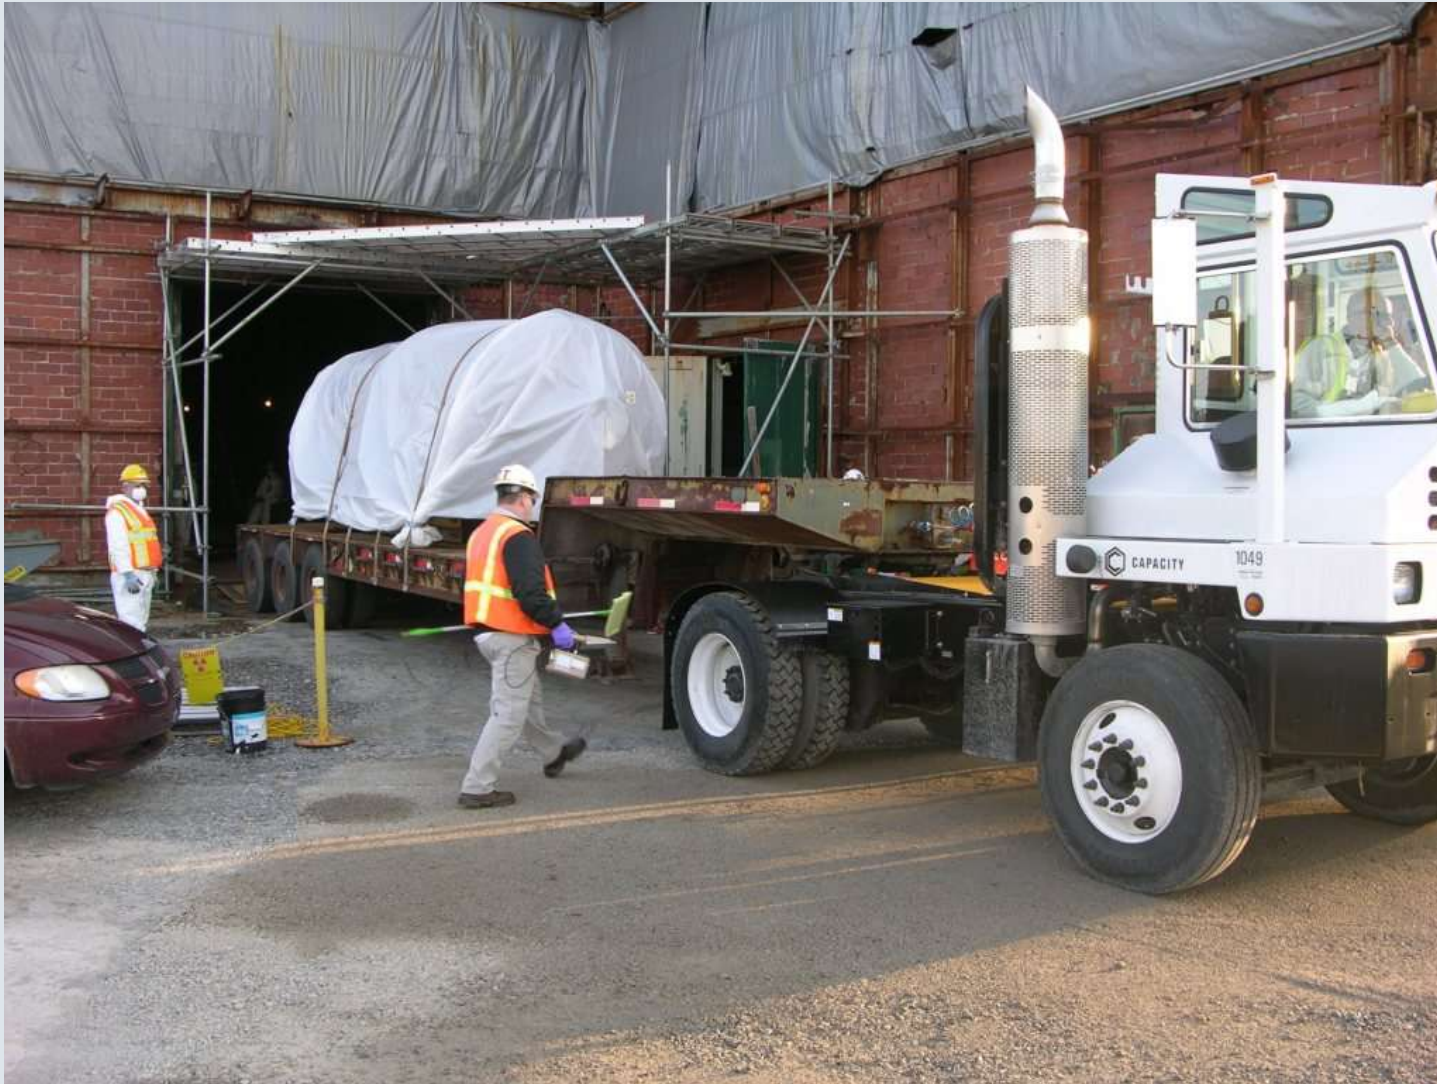
# Surge Tank Being Moved

## ☆ NDA group provide contemporary measurement results for each tank

- ☆ Used visual inspection results to more accurately model the configuration of deposition within a tank
- ☆ High purity Germanium (HpGe) detector with the In-Situ Object Counting System (ISOCS)

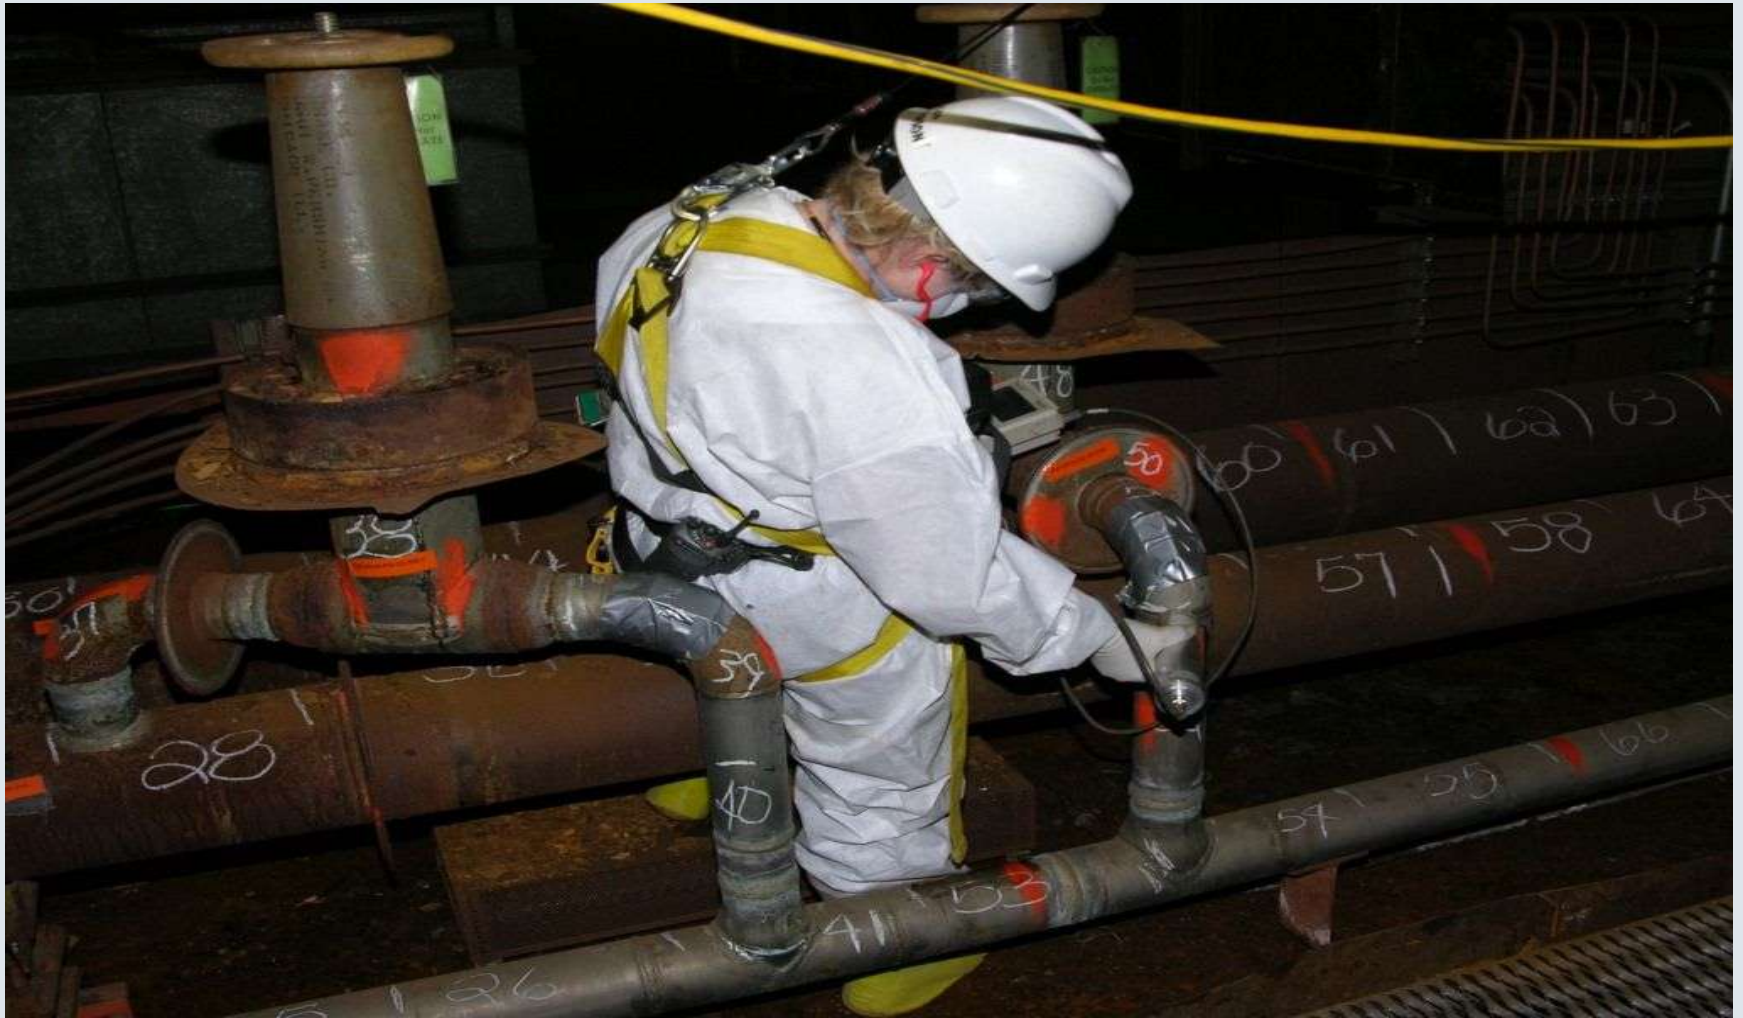
# G-17 Valve (4 inch diameter)

- ★ ~ 5000 G-17 valves existed in K-25
- ★ Range from 3 to 14 inch diameter

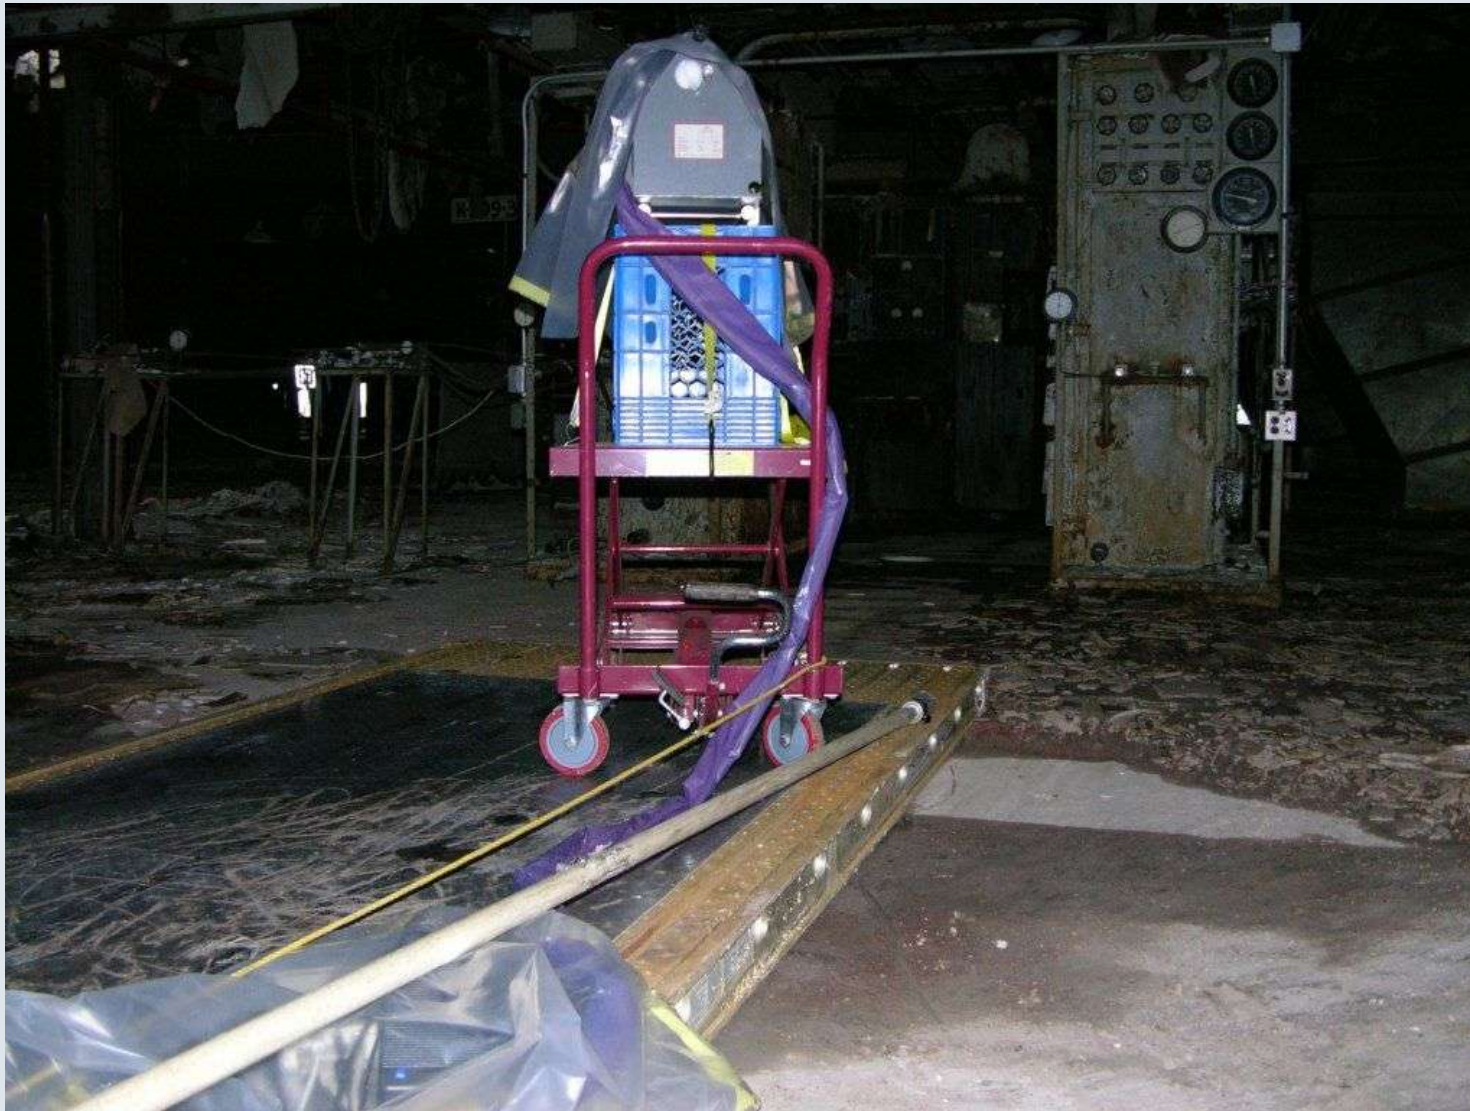
# Line Recorder Manifold Cabinets

- ☆ Each of the Line Recorder Manifold Cabinets were measured with qualified NDA instrumentation
- ☆ Only one exceeded burial ground  $^{235}\text{U}$  mass criteria
- ☆ Enabled the demolition of the East Wing and North End of the building to be performed under a criticality incredible determination

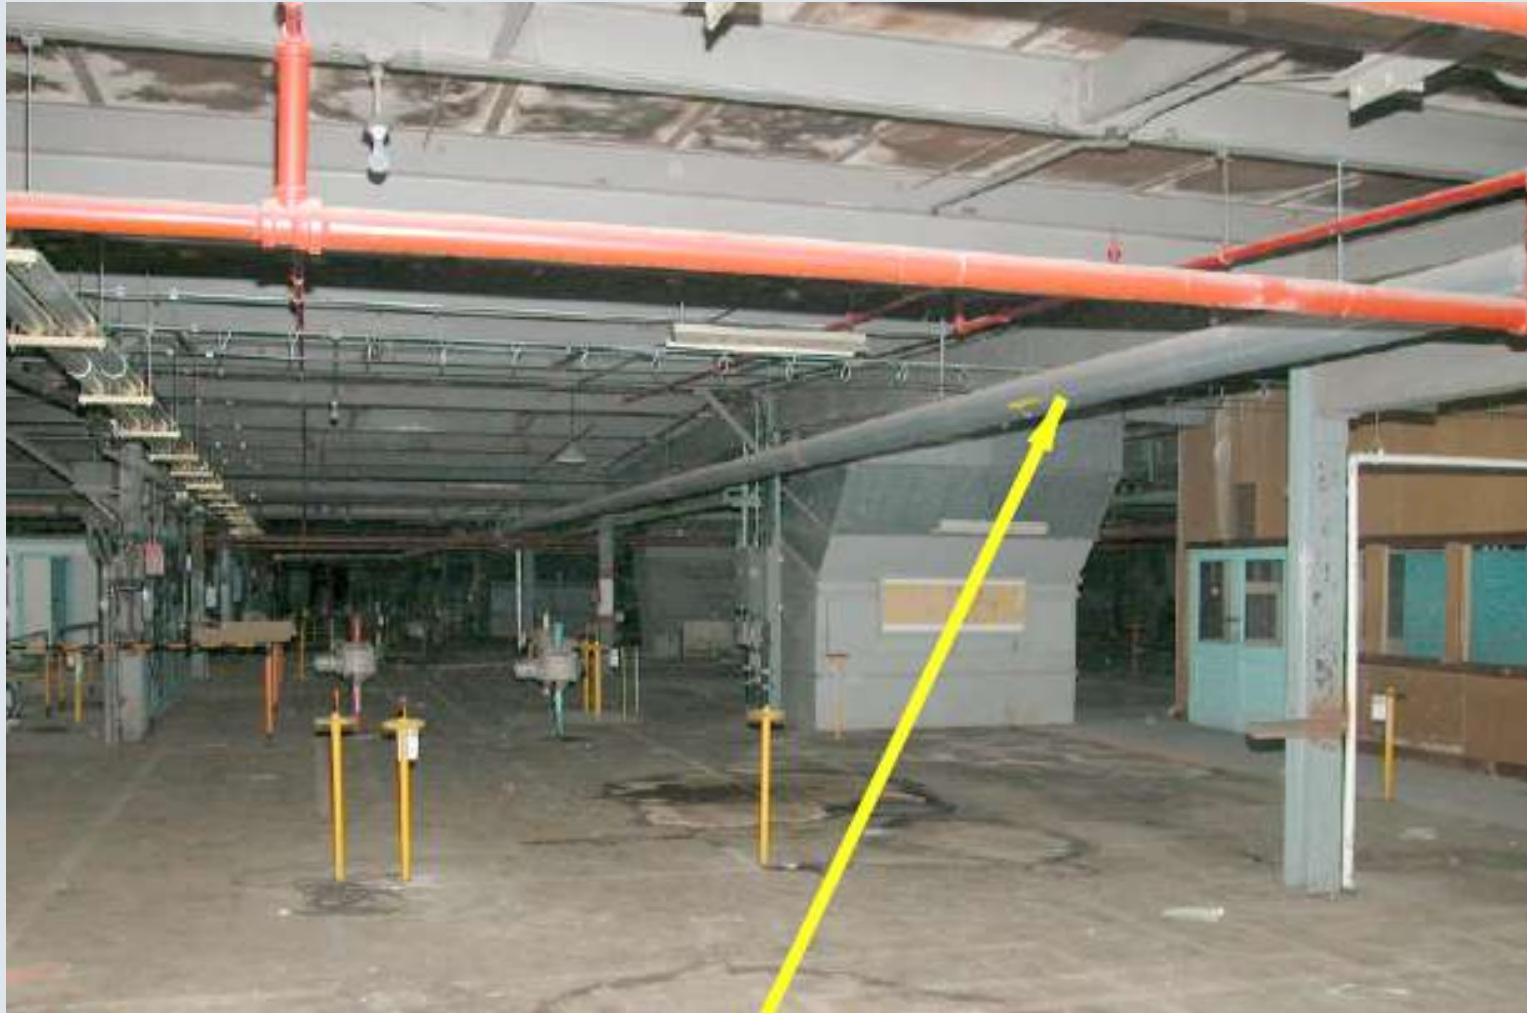
# UF-6 Evacuation Line

- ☆ Four inch diameter line between K-1423 and K-27
- ☆ Process knowledge indicates rarely used
- ☆ No ties to the K-25 building process gas system

- ☆ It is on the operations floor of East Wing; therefore, inaccessible since 2006.
- ☆ No existing characterization to approve it for demolition or for burial at Environmental Management Waste Management Facility (EMWMF)

- ☆ Goal was to show the pipe contains less than 10 g  $^{235}\text{U}$  per foot of pipe (EMWMF burial criteria for 4 inch diameter pipe)
- ☆ Measure directly each foot outside K-25 in the tie line areas
- ☆ Set up HpGe/ISOCS at the tops of certain stairwells and measure as much length of pipe as can fit in the field of view
- ☆ Use man lifts from outside the building at various locations to aim HpGe/ISOCS at the pipe
- ☆ Low background on operations floor level, combined with longer count times would hopefully offset some of the large stand-off distances (10 to 50 feet)

- ☆ Approximately 38% of the length of the pipe in the building was systematically characterized through these methods
- ☆ Each measurement result indicated the average g/ft of pipe was less than half the EMWMF burial criteria
- ☆ NCS was able to claim when combined with process knowledge that this pipe would not lead to a criticality during either demolition or disposal at EMWMF
