Concurrent Uranium Overmass and Hydraulic Fluid Leak

Travis Wilson and Jerry Lichtenwalter
Y-12 Nuclear Criticality Safety

Overview

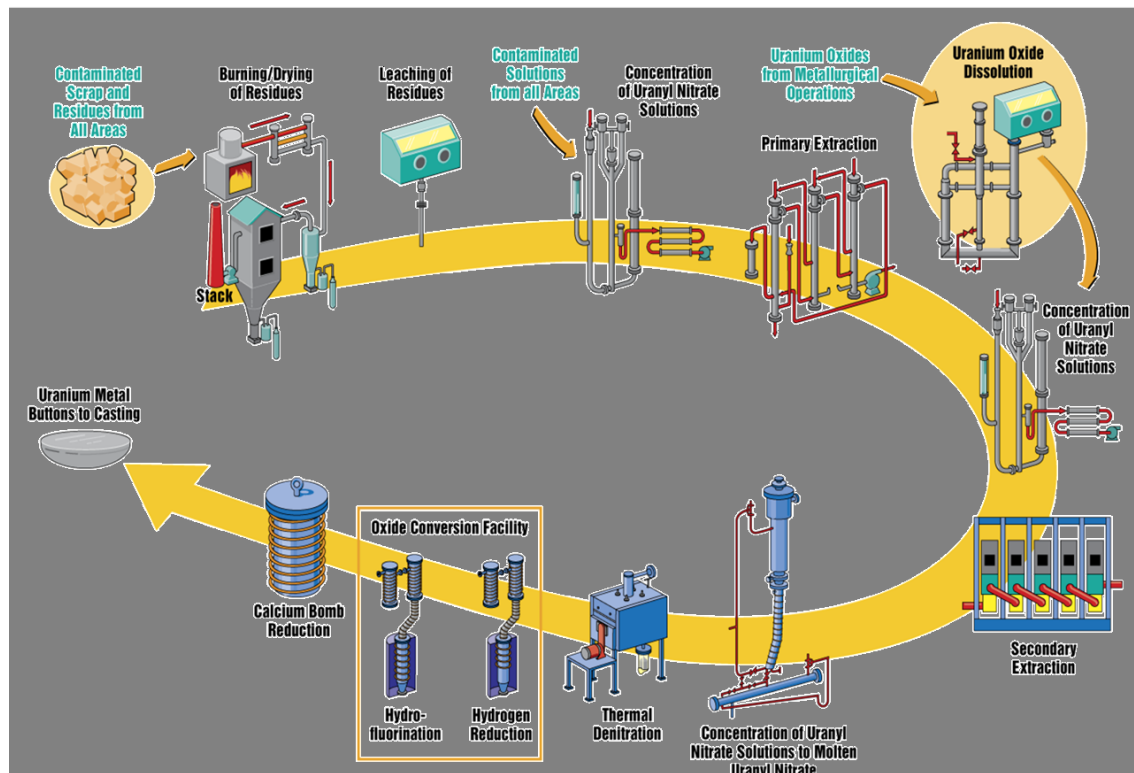
- Process involves the reduction of UF_4 to a relatively pure uranium metal button and CaF_2 slag

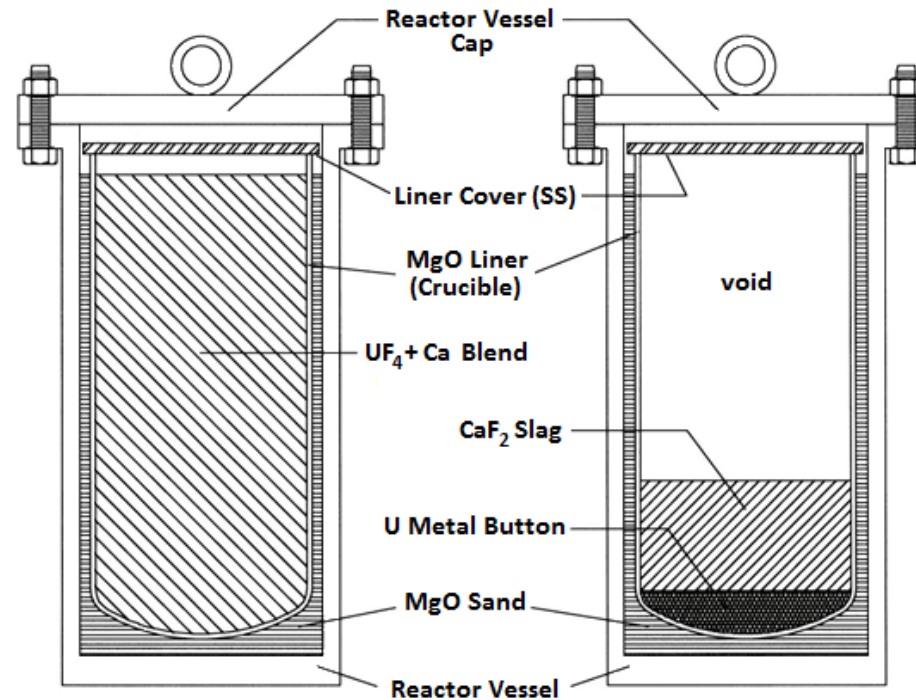
- Reduction takes place in a stainless steel reactor vessel with a MgO liner and sand

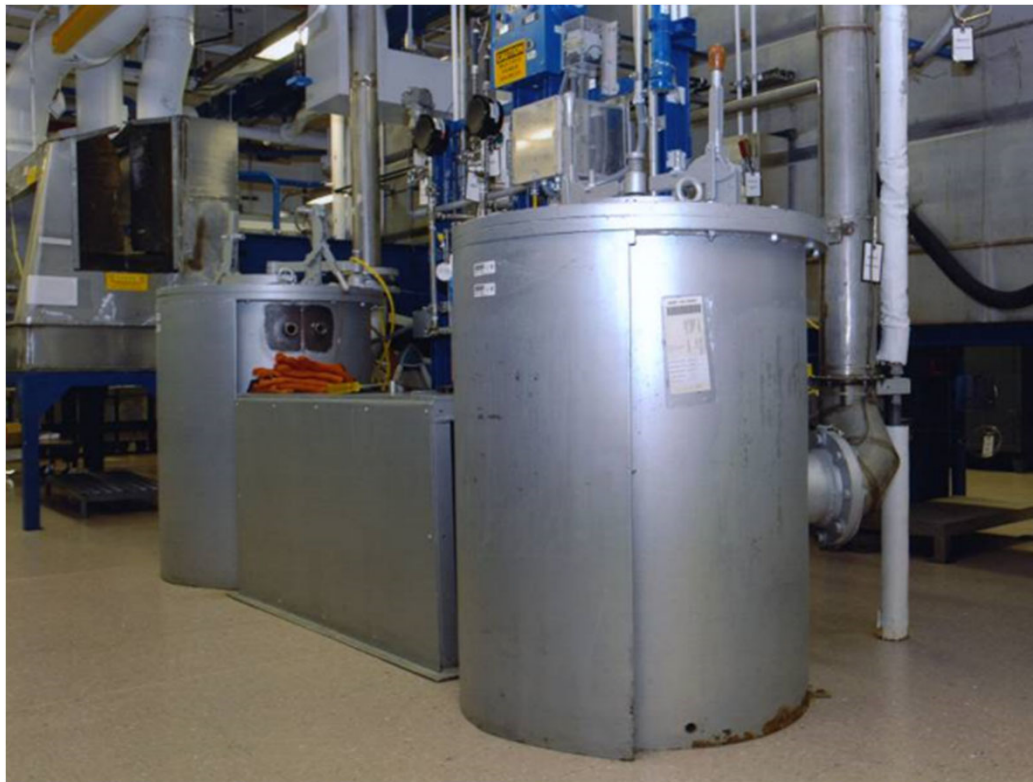
- Vessel is heated in an induction furnace and cooled

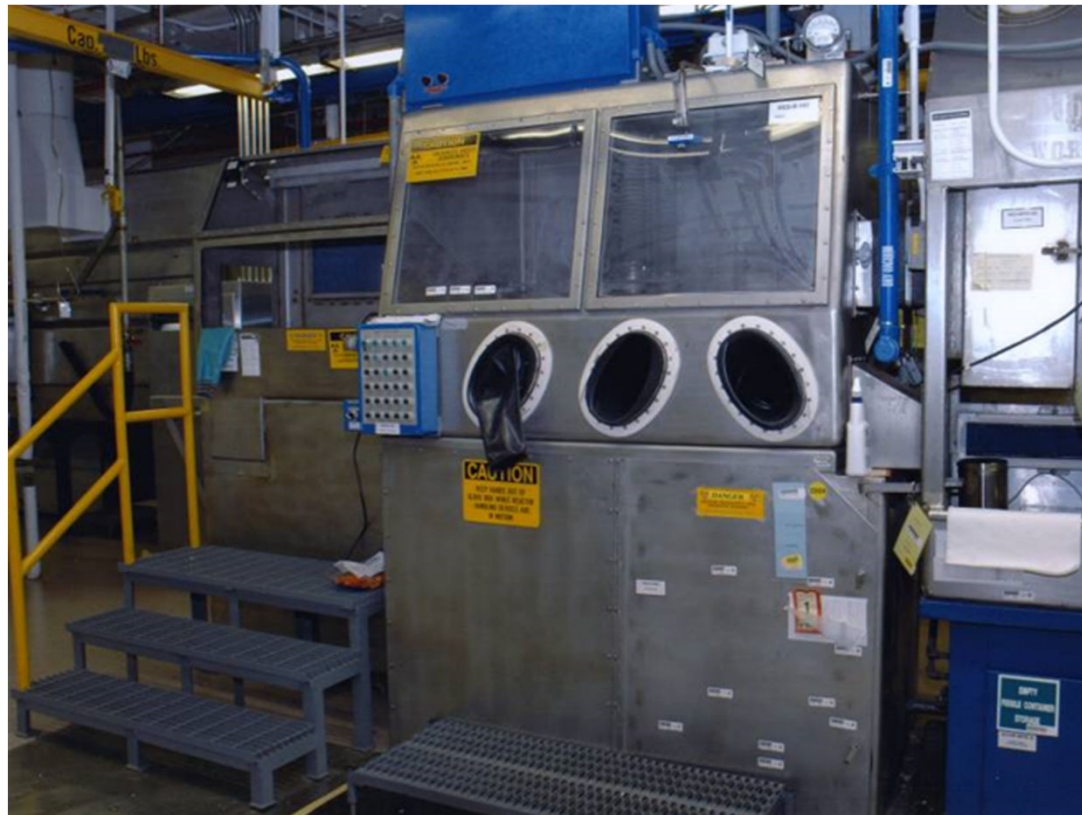
- The vessel is transported to a Knockout Glovebox

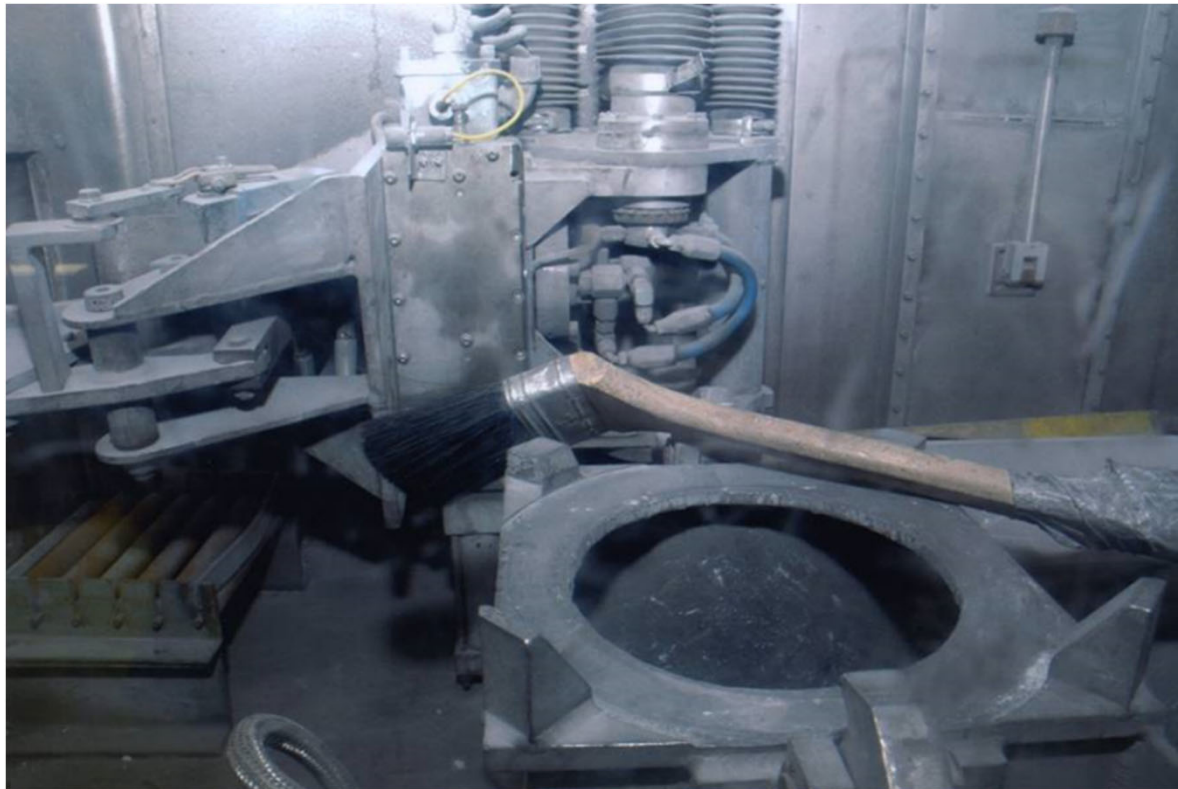
- Vessel contents are “knocked-out” using a hydraulically operated jolter

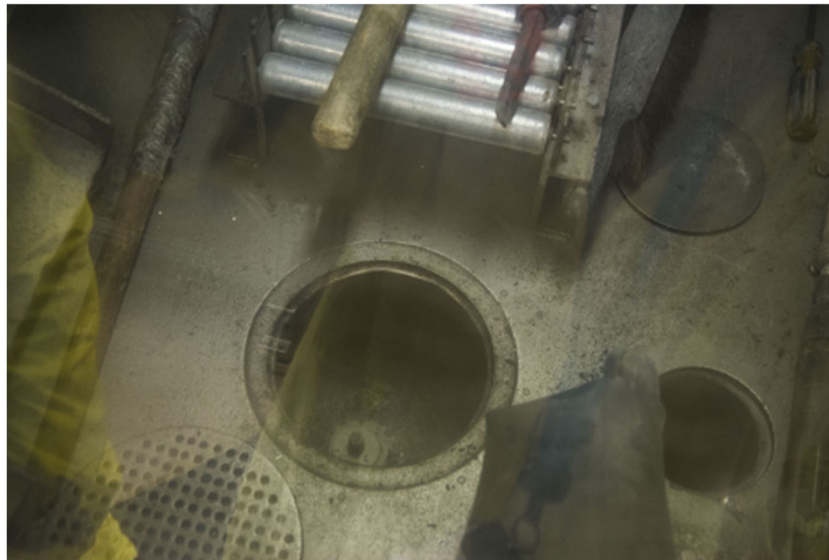
- Liner, uranium-bearing slag, and uranium-contaminated sand are processed separately
 - Sand is fed through a chute to a vibrating sieve-like sand separator
 - Slag and the MgO liner are sent down a separate 6" diameter chute directly to accumulation can

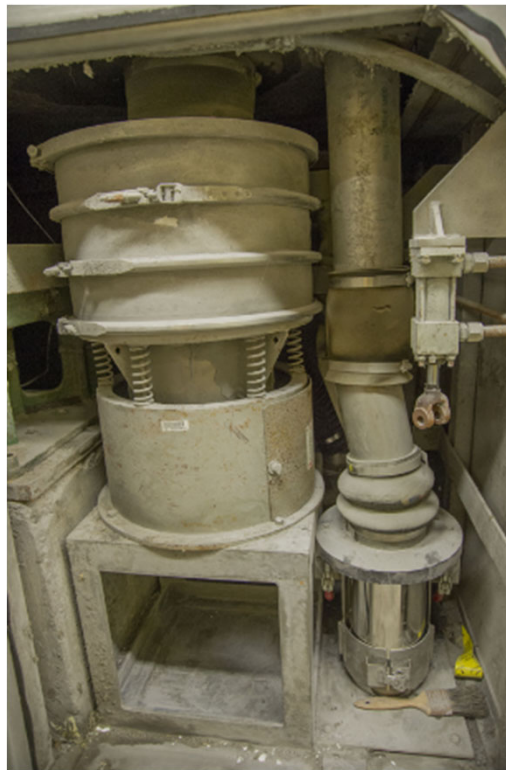
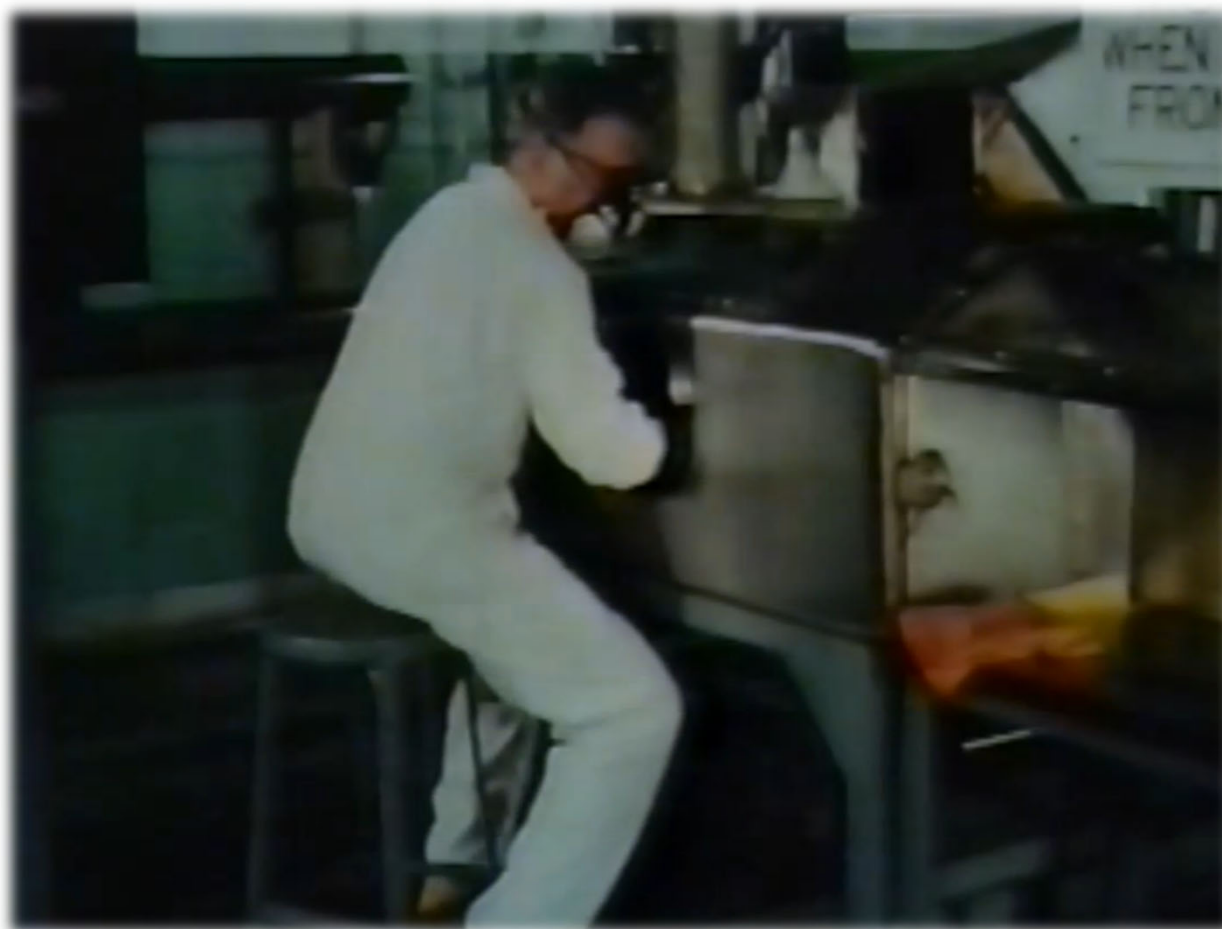
- The sand separator has 3 levels that separates large particles, sand, and fines

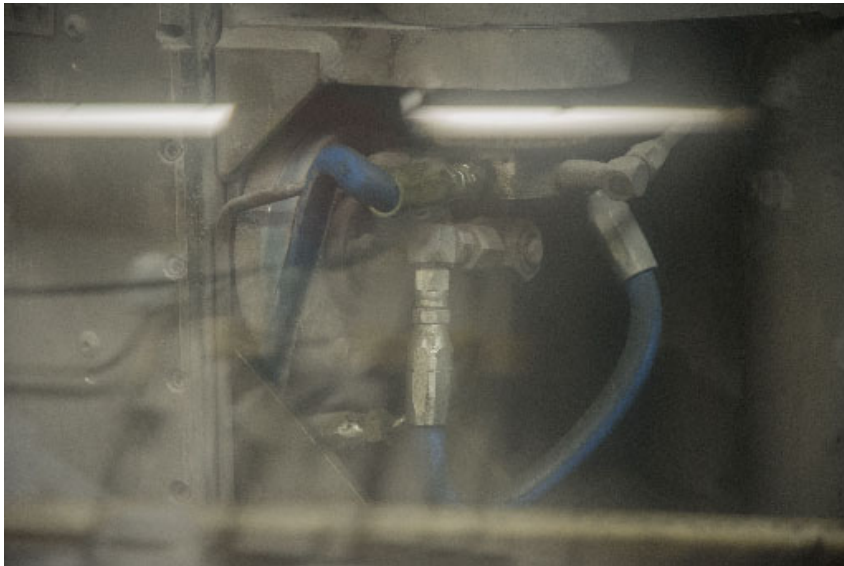
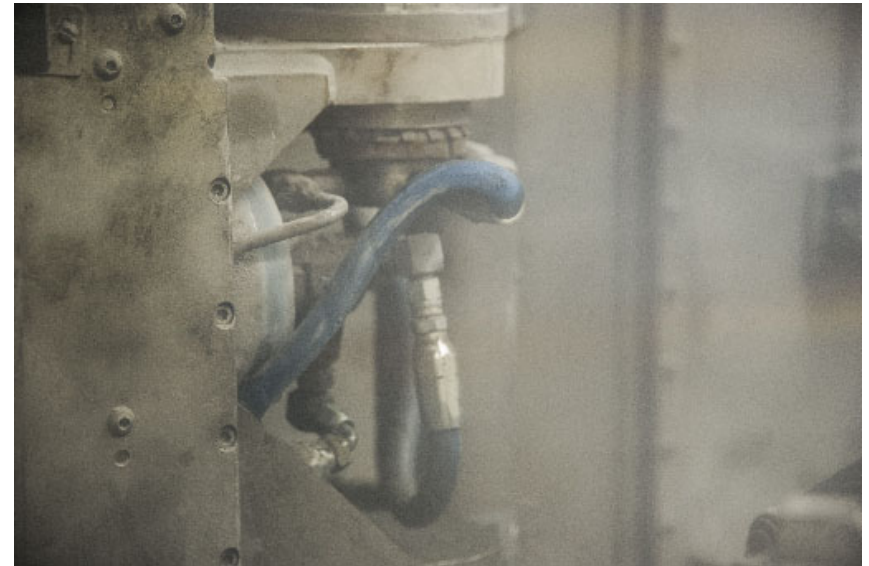
- Hydraulic leaks on the jolter occurred in April and May of 2017

- Installed new, more robust hydraulic lines
- Installed plugs for both chutes
- Limited the hydraulic fluid reservoir
- Installed a glovebox drainage system

- 700 g U limit established for the accumulation can, sand separator, 3" diameter chute, and 6" diameter chute
- Glovebox must be inspected for hydraulic fluid prior to use
- Sand chute plug is required to be in place at all times except when transferring sand to the sand separator
- Slag chute plug is required to be in place at all times
- All uranium materials must be removed before another vessel is introduced to the glovebox

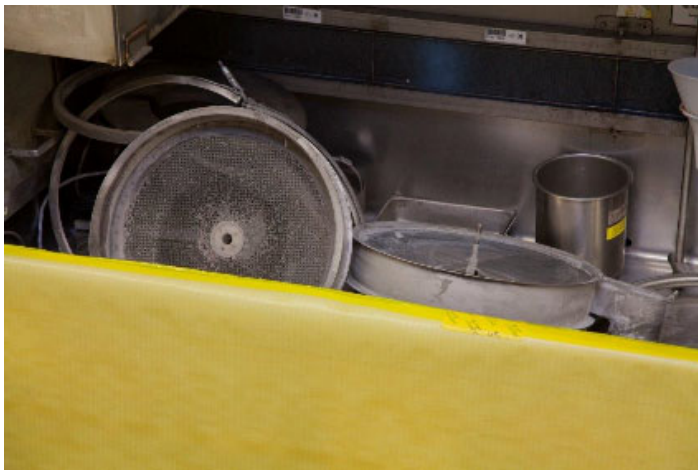
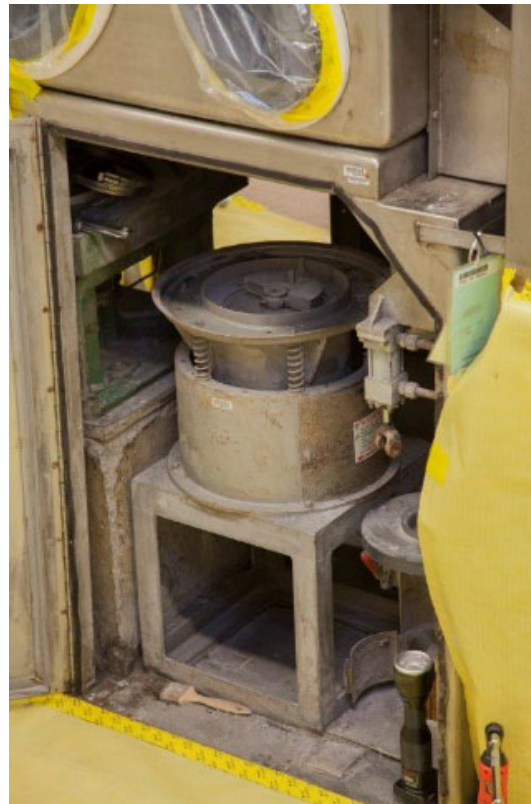
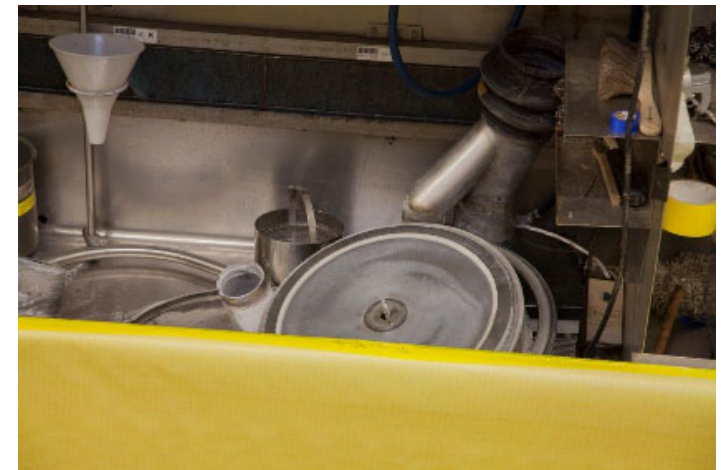
- Disassembled components and collected material in a nearby hood

- Total mass collected was over 30 kg
 - U-235 mass was ~3.5 kg

Section	Net Mass	U-235 Mass
Accumulation Can	~10000 g	1226 g U-235
Bottom of Sand Separator	9098 g	864 g U-235
Middle of Sand Separator	640 g	23 g U-235
Top of Sand Separator	33 g	33 g U-235
6 in Chute	2861 g	291 g U-235
3 in Chute	9395 g	1149 g U-235

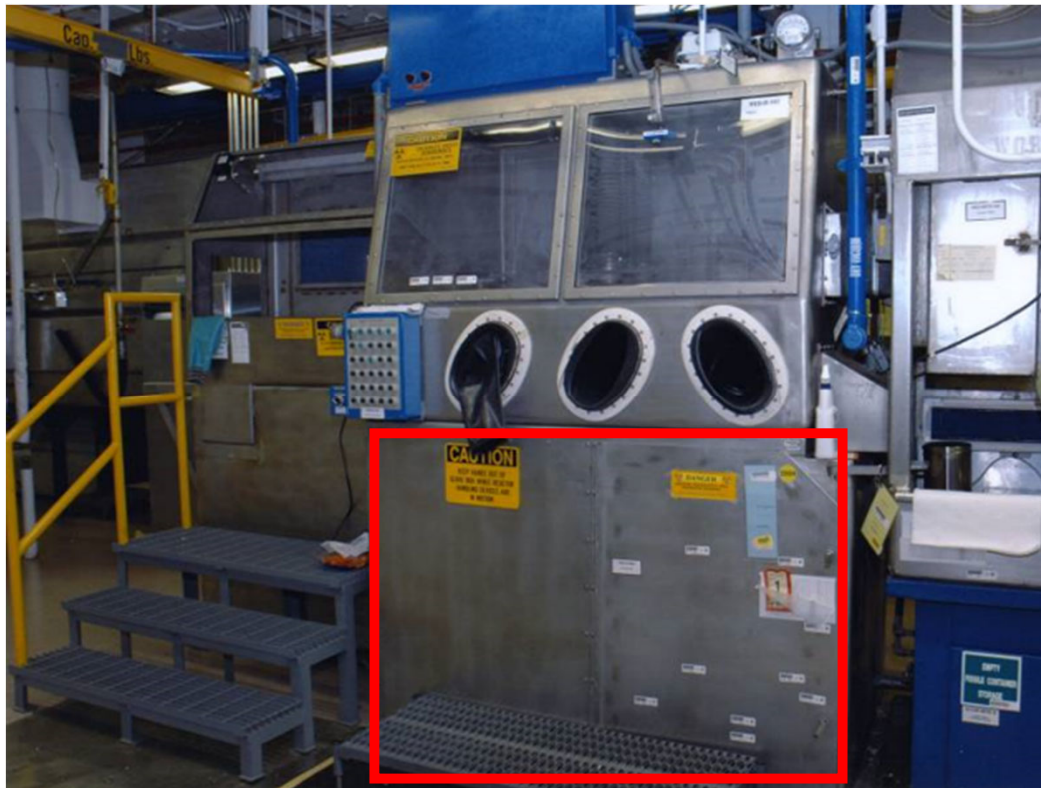
- Operating procedure did not have requirements for emptying the accumulation can

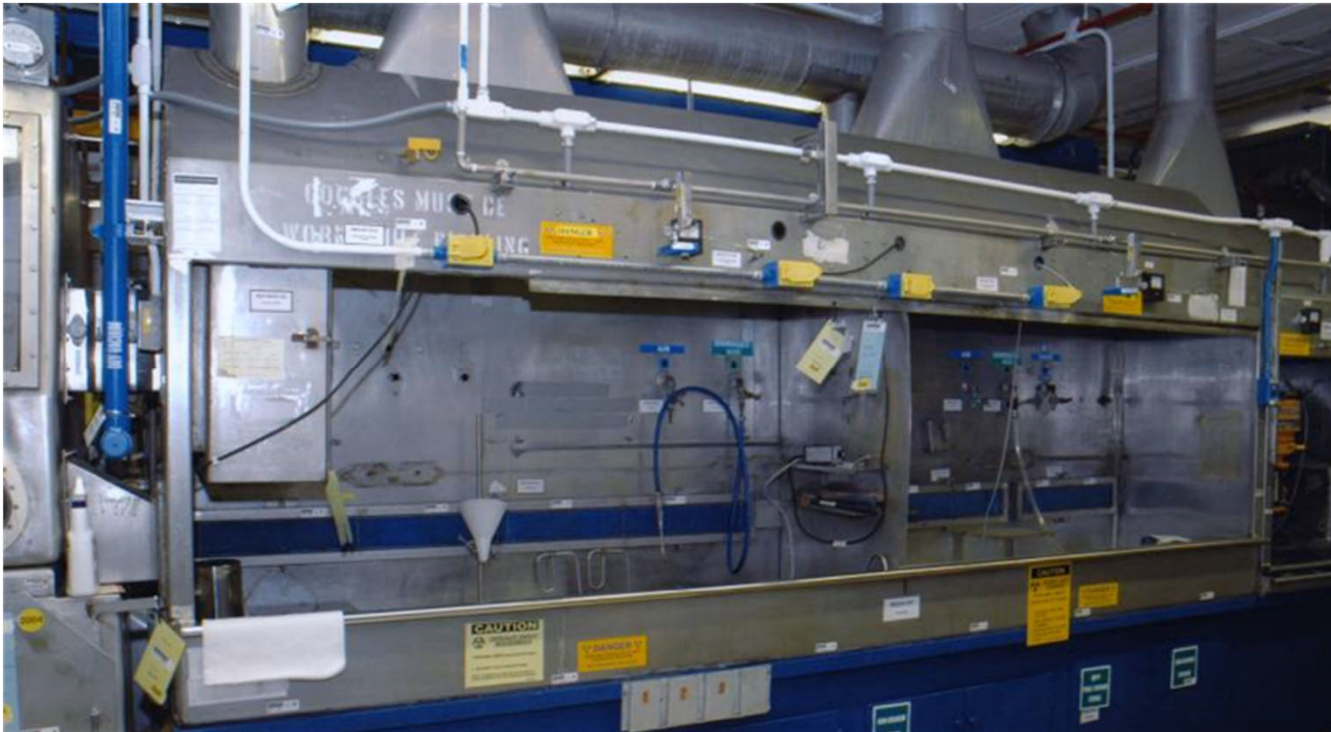
- Method for collecting slag changed from collecting in the accumulation can to collecting in a can on the glovebox floor

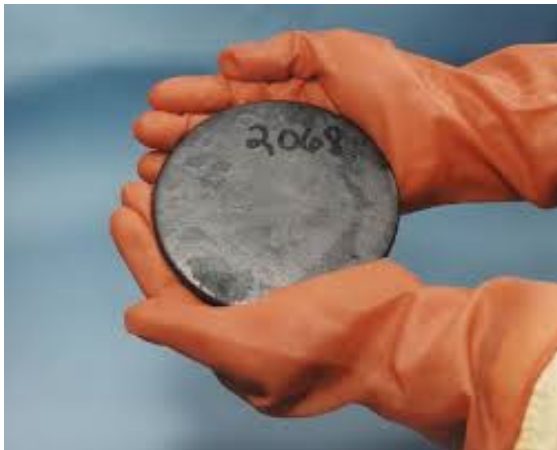
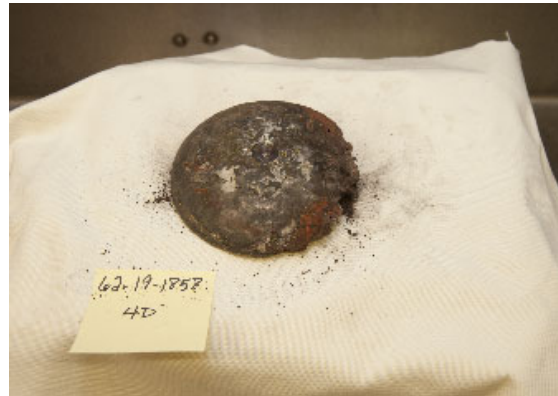
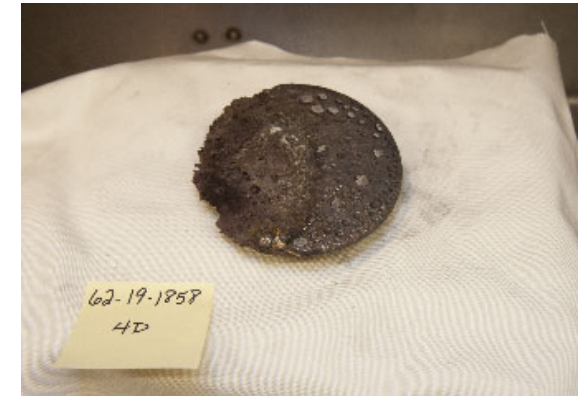
- Reduction process drifted from producing intact buttons to occasionally producing low quality or multi-piece buttons

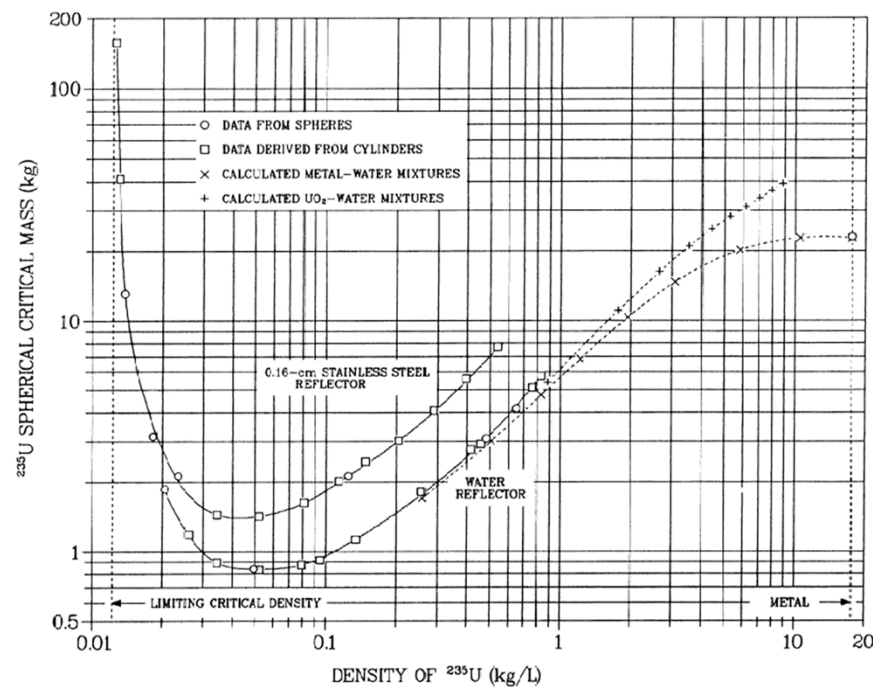
- No NCS analysis or controls on mass or moderation of material collected in the sand separator

Fig. 10. Critical masses of homogeneous water-moderated $\text{U}(93.2)$ spheres. Solution data appear unless indicated otherwise.
