# Evaluation of Neutron Absorber Panels from Zion Spent Fuel Pool

Hatice Akkurt<sup>1</sup>, Matt Harris<sup>2</sup>, Ashleigh Quigley<sup>2</sup>

<sup>1</sup>Electric Power Research Institute (ERI)

ANS Winter 2016 November 8, 2016

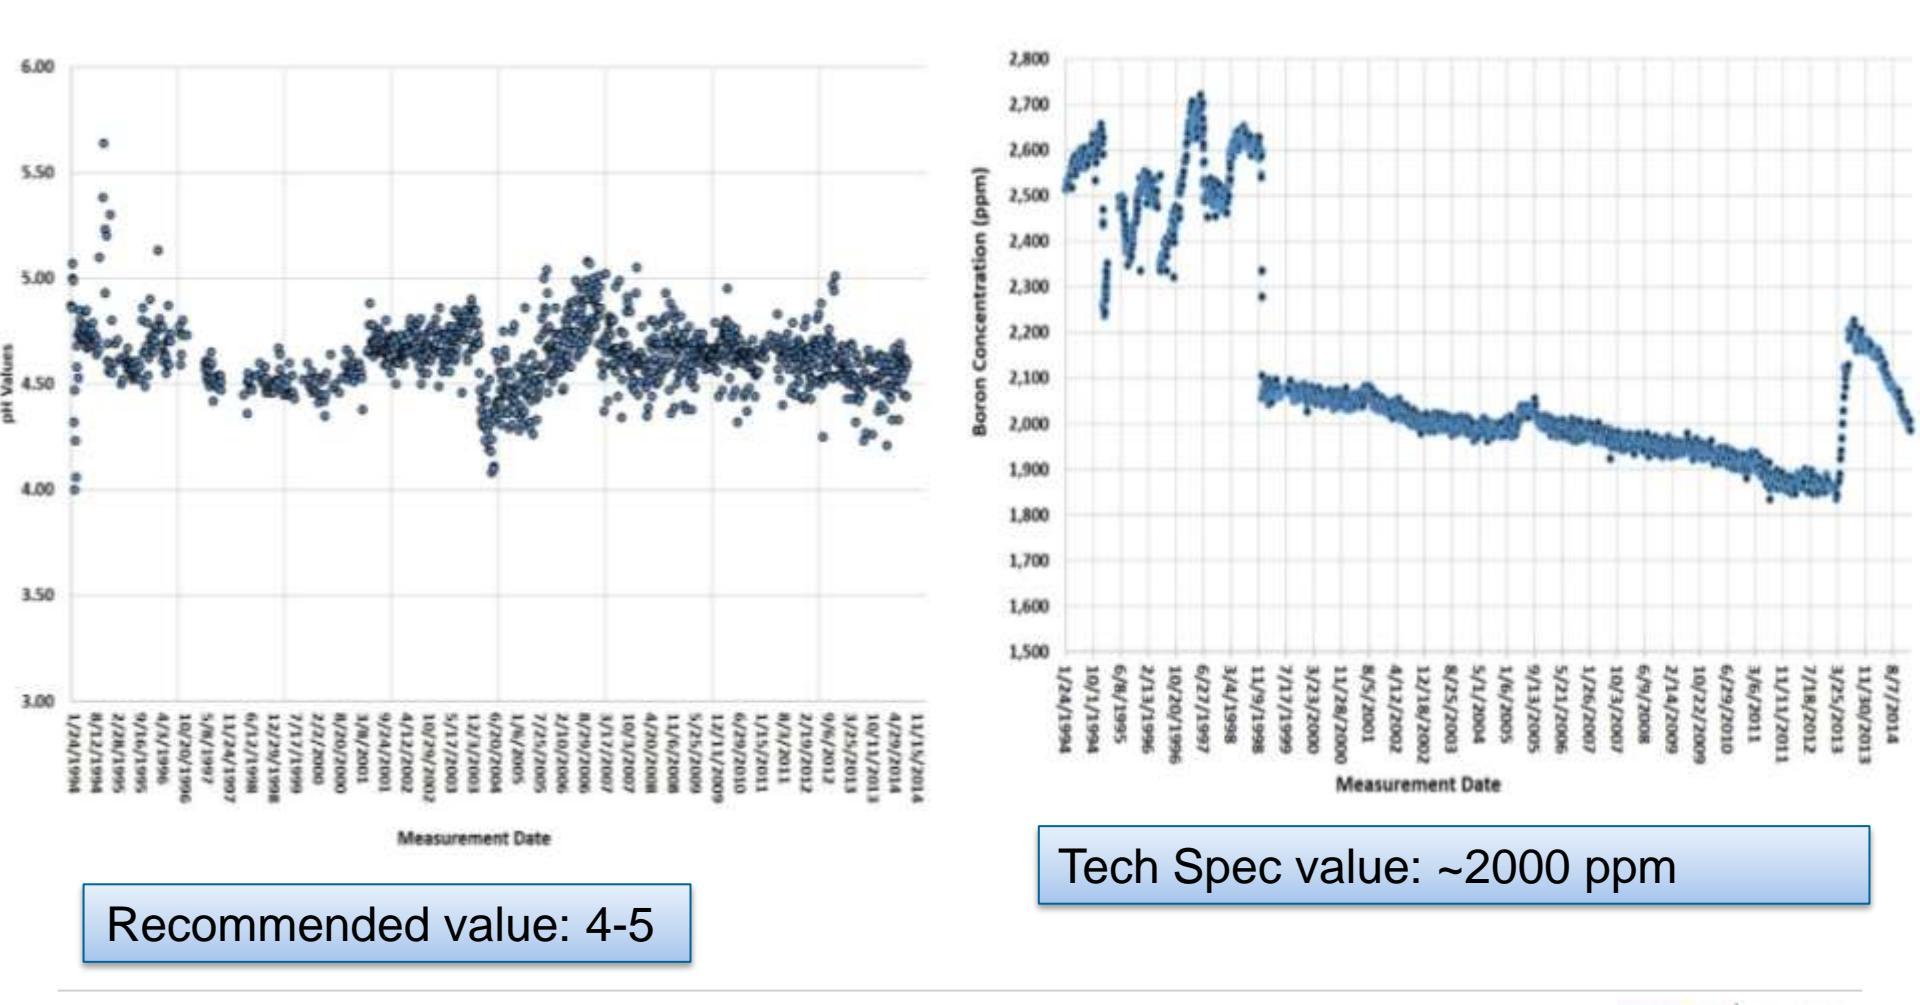
## **Zion Water Chemistry**

Water chemistry measurements performed every 7 days; unless need for more frequent measurements

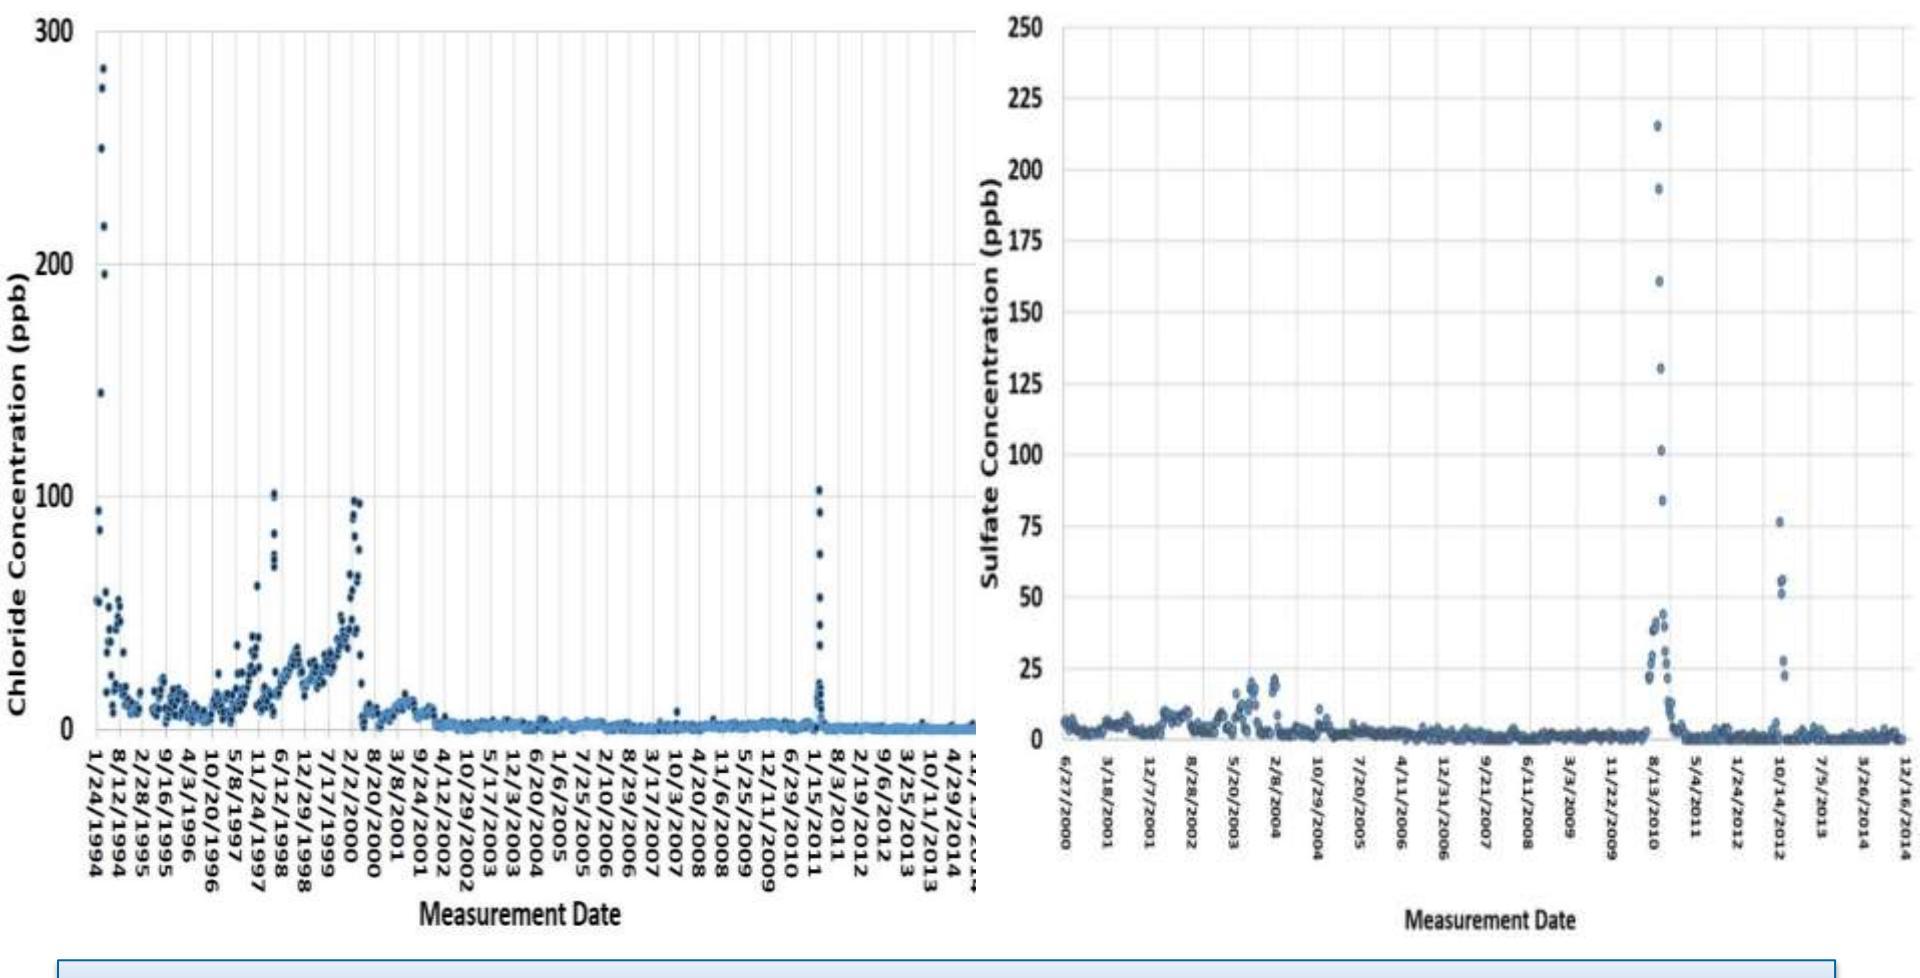
## **Zion Water Chemistry**

Based on EPRI water chemistry guidelines: CI & Sulfate concentration < 150 ppb

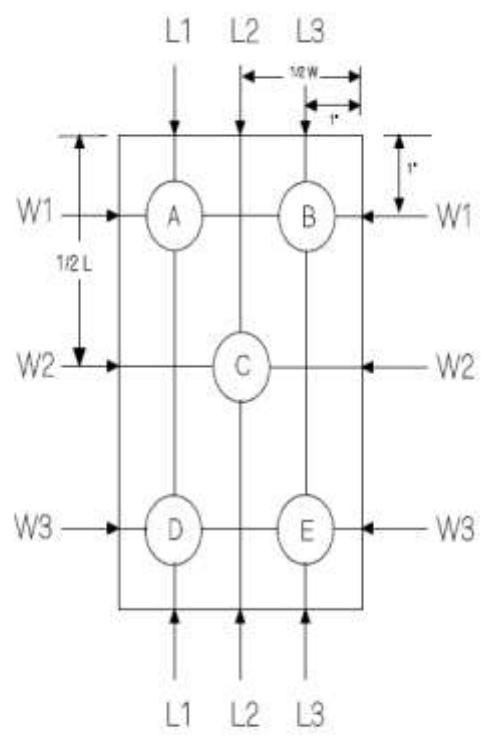
## **Zion Coupons**

- Coupon Tree removed from Zion SFP
- 10 coupons shipped to PSU for analyses
  - Access to previous coupon measurement reports

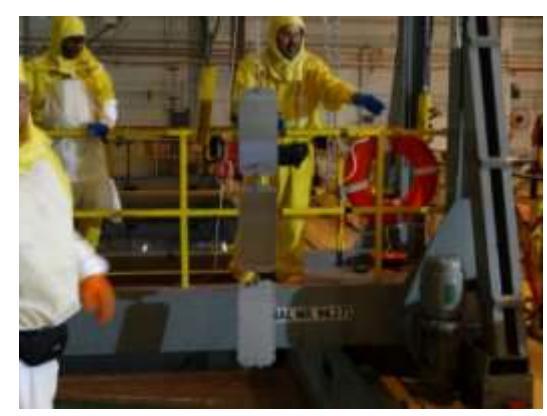
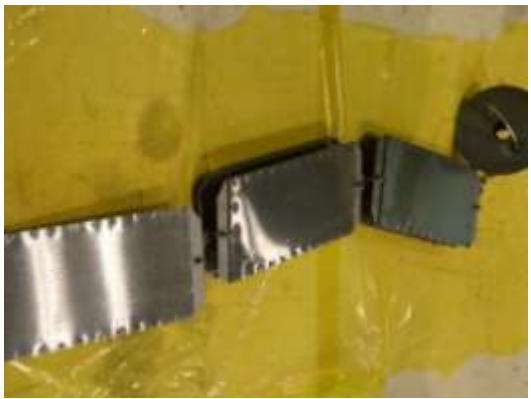
- Length measurements: L1, L2, L3
- Width measurements: W1, W2, w3
- Weight, thickness, density measurements

- After Irradiation areal density measurements at 5 locations, A, B, C, D, E
- Pre-irradiation areal density measurements at 3 locations, A, C, E

- Coupon L = 15" +/- 0.063";
  W = 7.5" +/- 0.063"
- All coupons were encapsulated using SS
- <u>Thickness:</u>
  - Region 1: 0.101"
  - Region 2: 0.085".

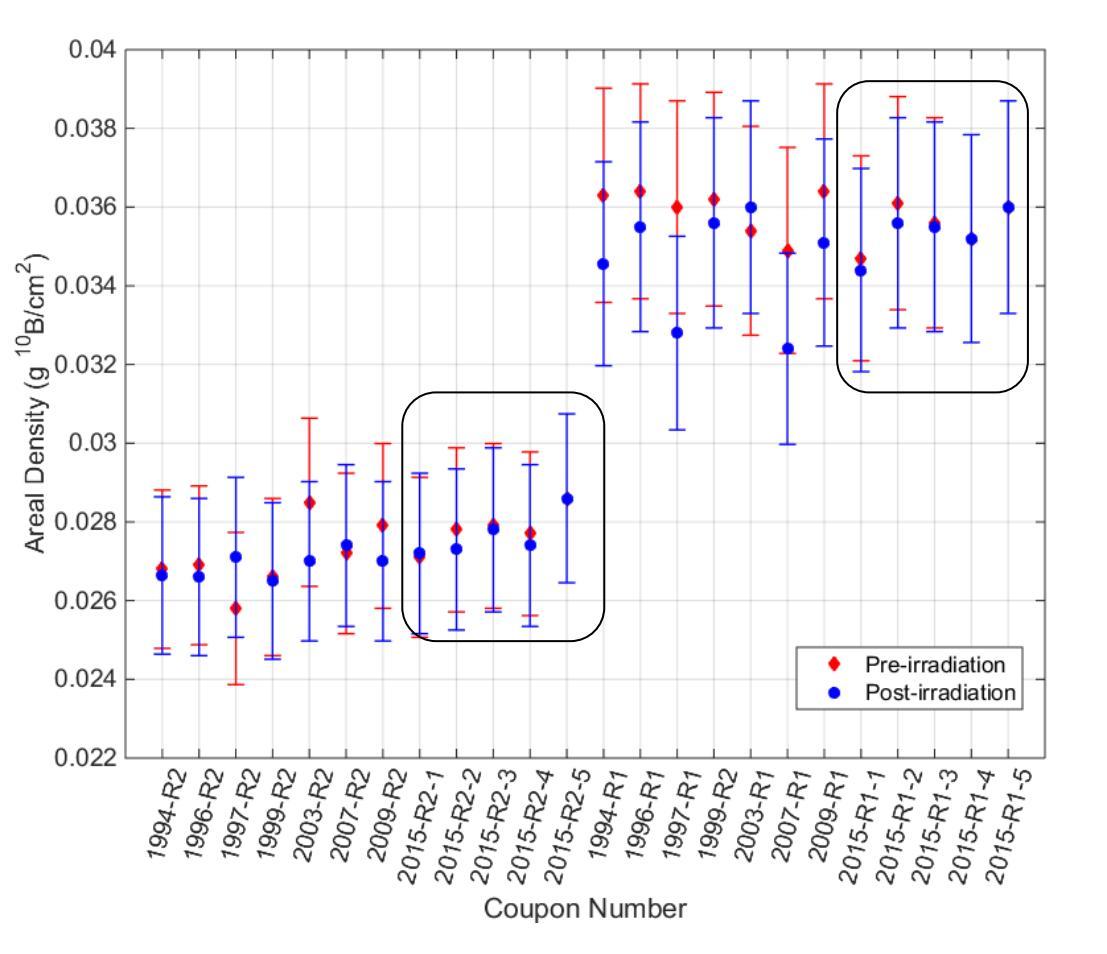
## **Zion Coupon Areal Density Measurements**

- Between 1994 and 2009, one coupon from each region was analyzed
- The areal density measurements from 2015 are compared to the previous coupons measurements, performed between 1994 and 2009
- The areal density measurements from 2015 are in excellent agreement with the pre-characterized values

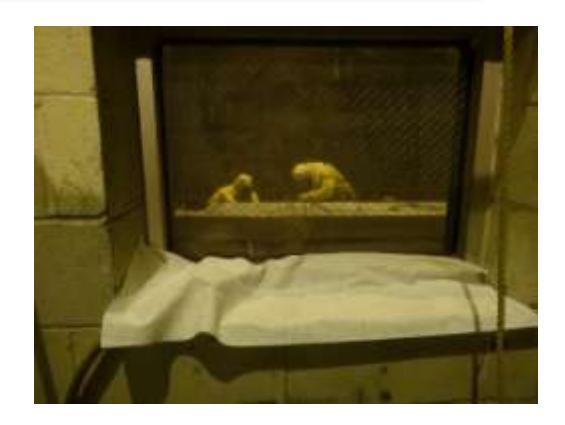
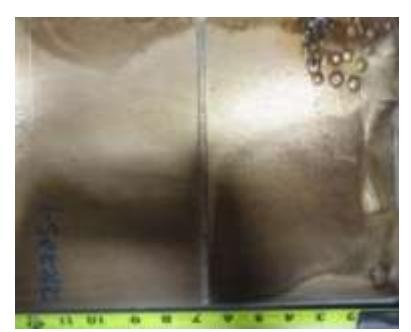
2K20S Panel damaged during cutting after removal from Zion SFP

- **Two modules** (one from Region1 and one from Region 2) removed from Zion SFP and shipped to Alaron for panel harvesting
- Based on BADGER measurements, 6 panels from Region 1 and 6 panels from region 2 were selected for analyses
- Two of the Region 1 panels were damaged during processing
- Those panels were kept for Areal Density measurements (to compare against BADGER) but two additional panels harvested for full analyses

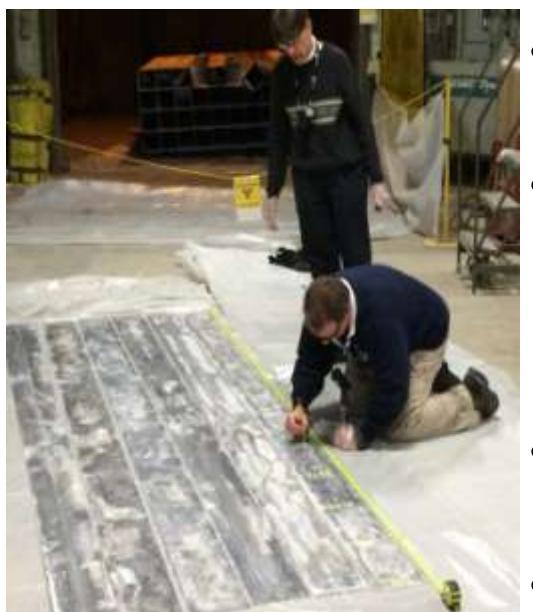
Region 2 panels are being measured, labeled, and marked for sectioning

- Each panel (144") divided into 12 sections
- EPRI & NRC received 6 sections/panel
  - Alternated between odd-even
    number for different panels
- EPRI panels shipped to PSU for analyses
- NRC panels shipped to SRNL for analyses

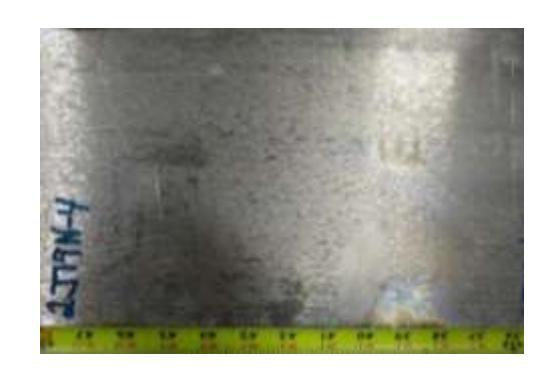
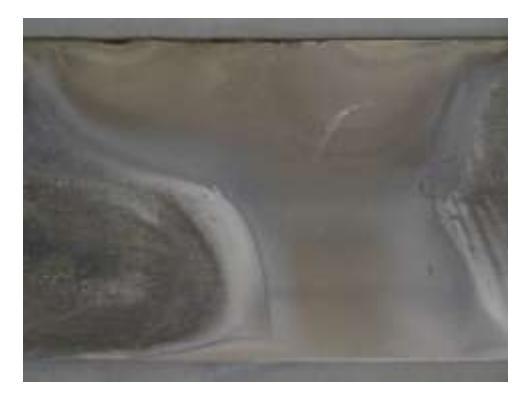
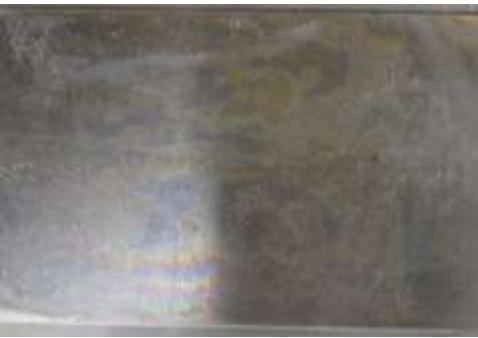
## **Overview of Condition of Panels**

Based on visual inspection, general observations are:

- With the exception of externally damaged panels, both Region 1 and Region 2 panels were in good condition
- Only one very small blister on one of the section of the panels (which was identified under microscope)
- Externally damaged panels showed blisters but those occurred after removal from the Zion SFP
- Showed general corrosion, flow patterns, some pitting but no evidence of significant degradation
- Overall, Region 1 panels were in much better condition
  - No SS encapsulation allowed a thick oxide layer formation, which acted as protective layer

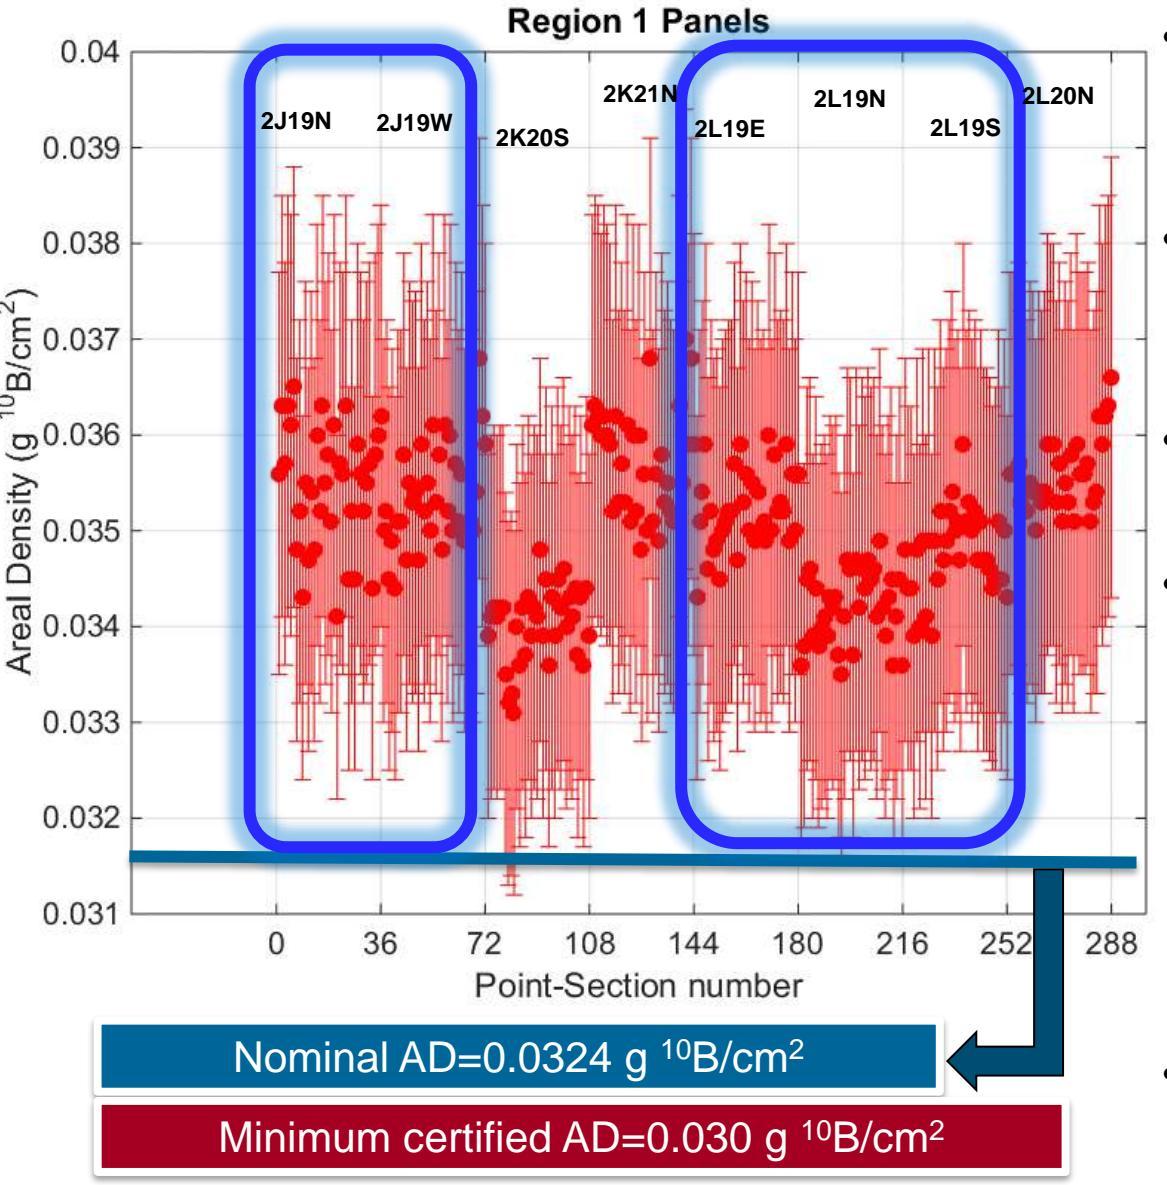
### **Region 1 Panel Areal Density (AD) Measurements**

- All of the measured AD values are above minimum certified AD values
- All of the **measured AD values** are **above nominal AD values** (error bars represent 3sigma)
- There are variations in AD within the same panel
- There are variations in AD for the panels that are in the same cell
  - 2J19N & 2J19W are from the same cell
  - 2L19E, 2L19N, 2L19S are from the same cell
- Panels 2K20S and 2K21 are the damaged panels

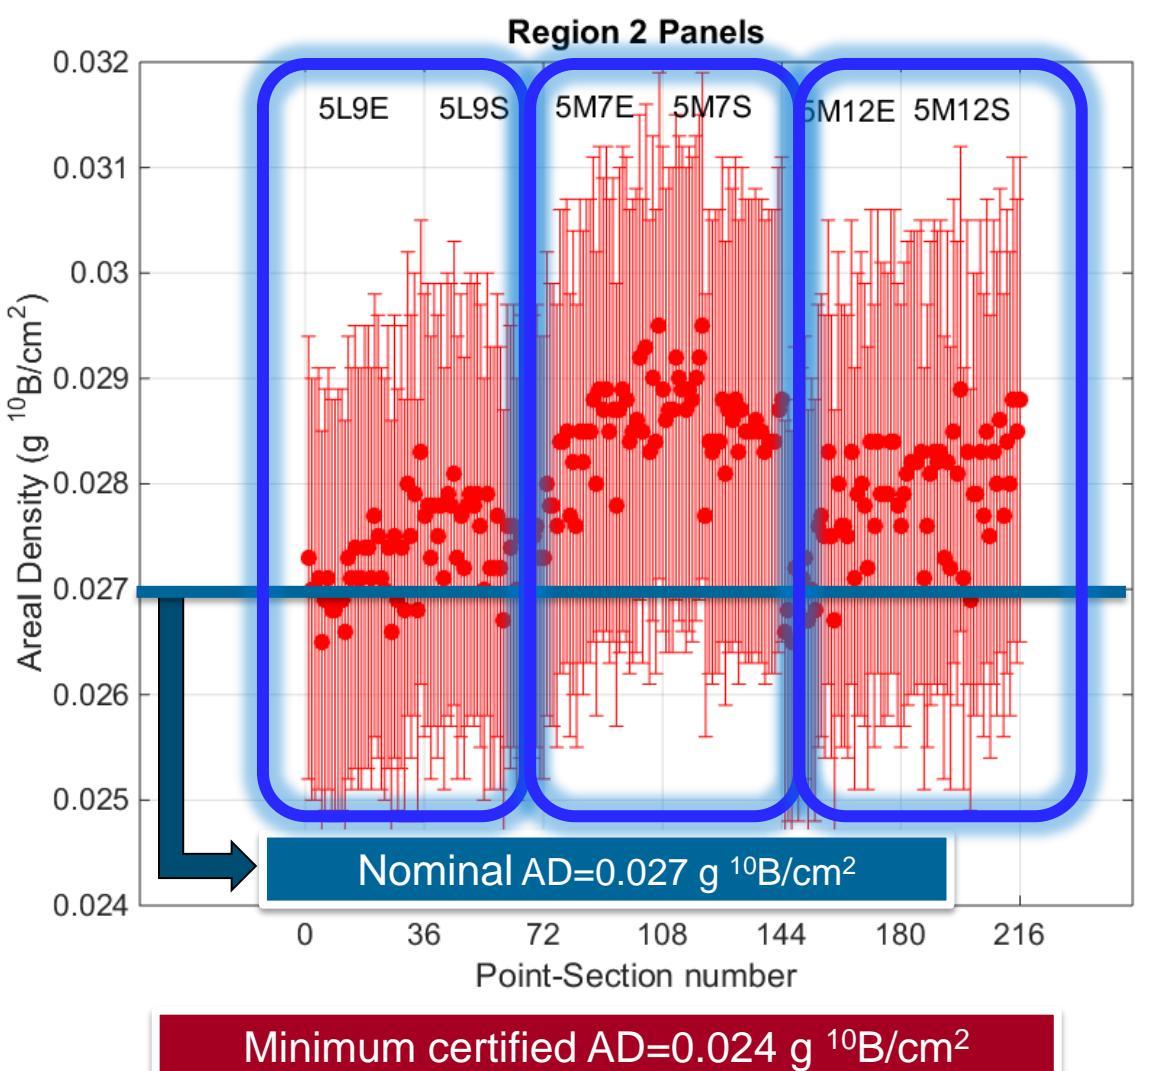
## **Region 2 Panel Areal Density Measurements**

- All of the measured AD values are above minimum certified AD values
- Few of the measured AD values are below nominal AD values (error bars represent 3sigma)
- There are variations in AD within the same panel
- There are variations in AD for the panels that are in the same cell
  - 5L9E & 5L9S are from the same cell
  - 5M7E & 5M7S are from the same cell
  - 5M12E & 5M12S are from the same cell

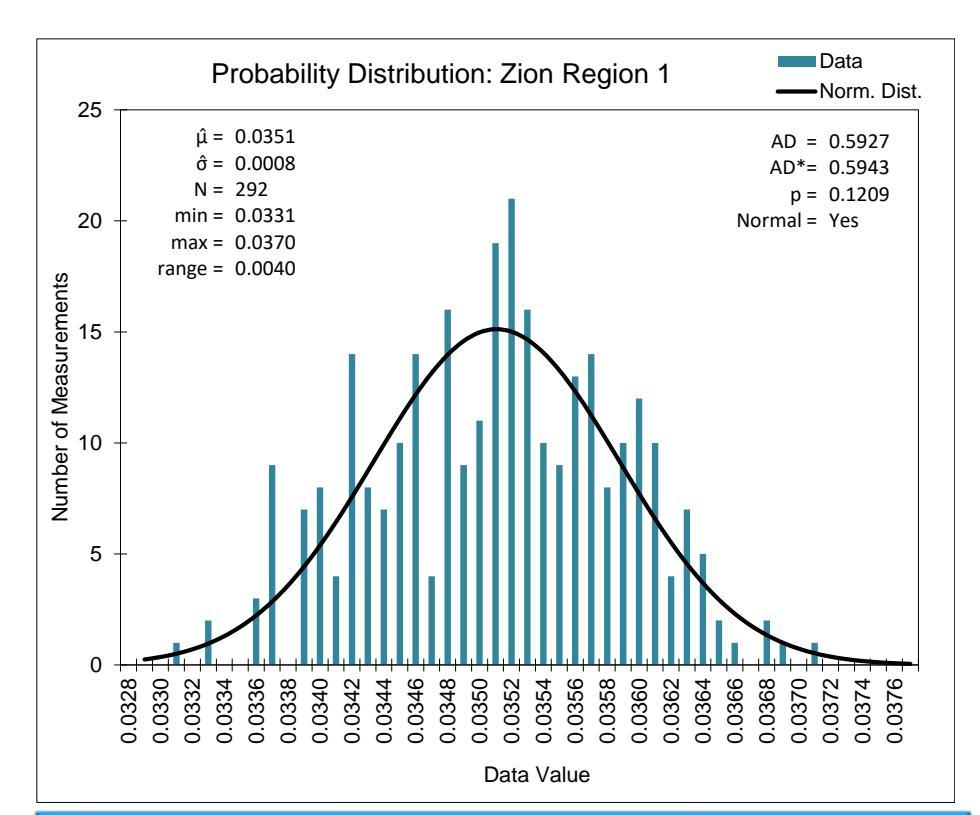
#### **Region 1 - Tech Spec:**

Min. certified AD=0.030 &

Nominal AD=0.0324 g <sup>10</sup>B/cm<sup>2</sup>

#### Region 1 – AD Measurements:

Min.=0.0331; Mean=0.0351; Max=0.0370 g<sup>10</sup>B/cm<sup>2</sup>

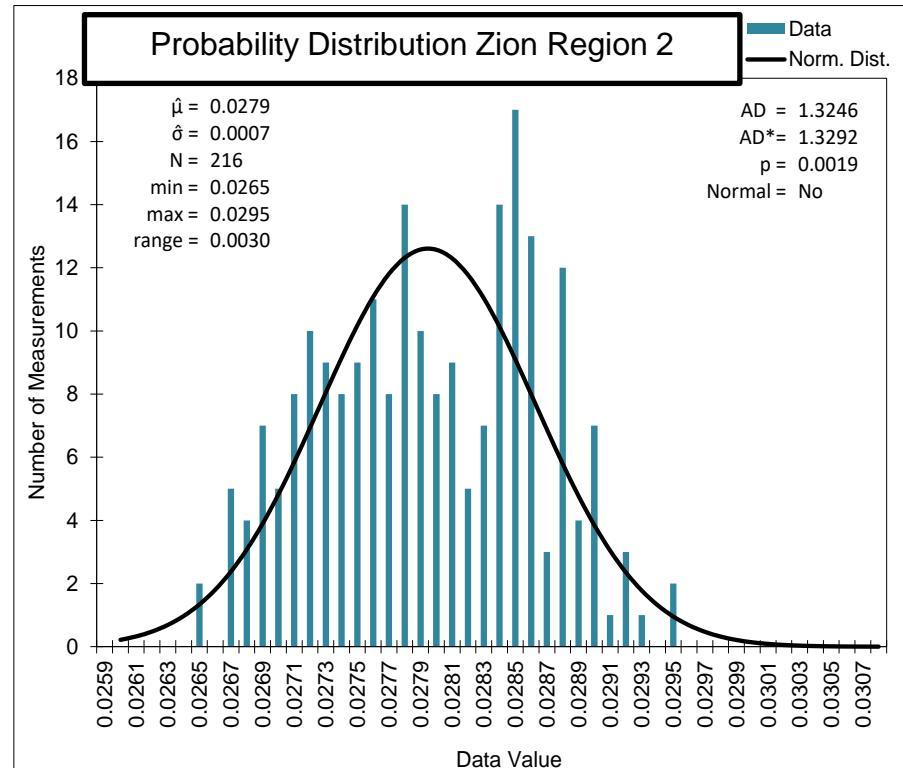
Region 2 - Tech Spec:

Min. certified AD=0.024 &

Nominal AD=0.027 g <sup>10</sup>B/cm<sup>2</sup>

#### **Region 2 – AD Measurements:**

Min.=0.0265; Mean=0.0279; Max=0.0295 g<sup>10</sup>B/cm<sup>2</sup>

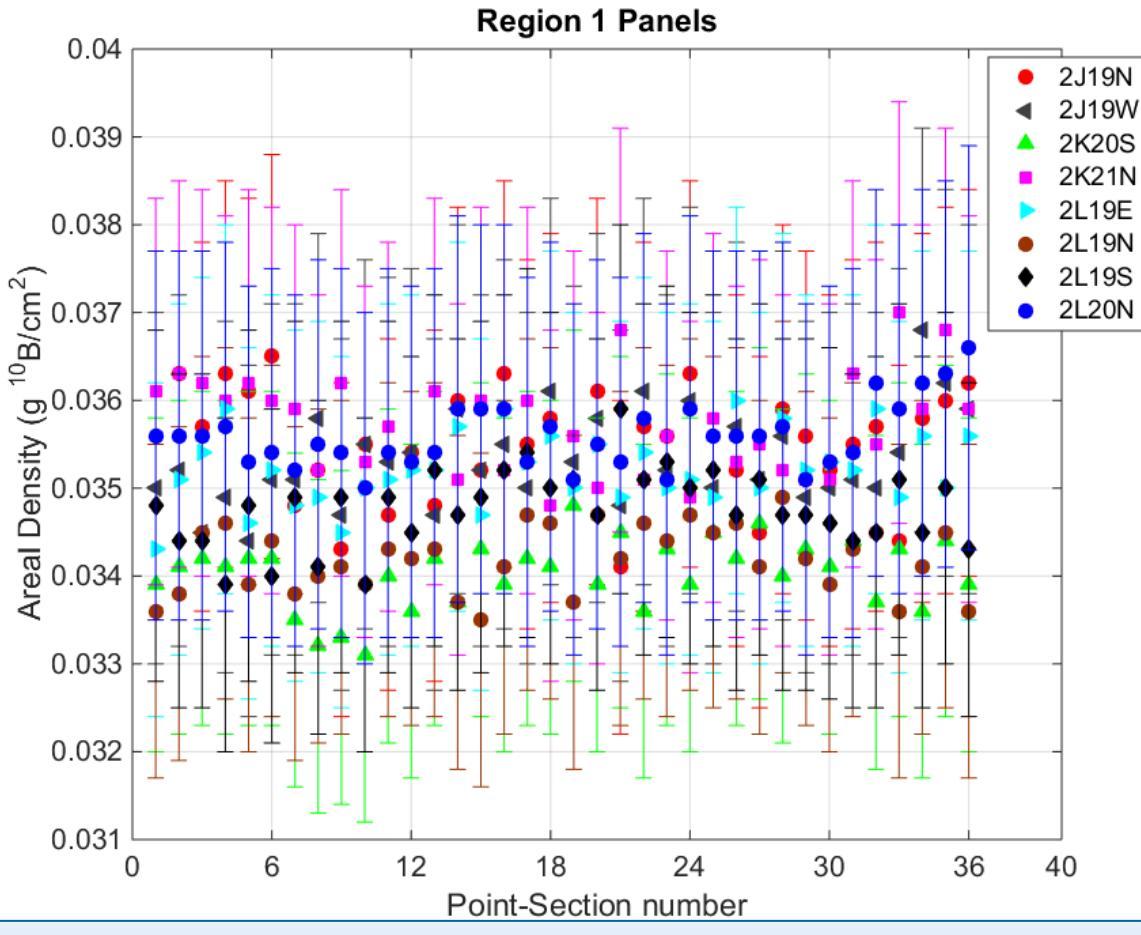
### Variations in Areal Density for Zion Panels – Region 1

#### **Variations in Areal Density**

- From panel to panel; for different points in the same panel; for different points within the same section
- No dependence in AD with axial height

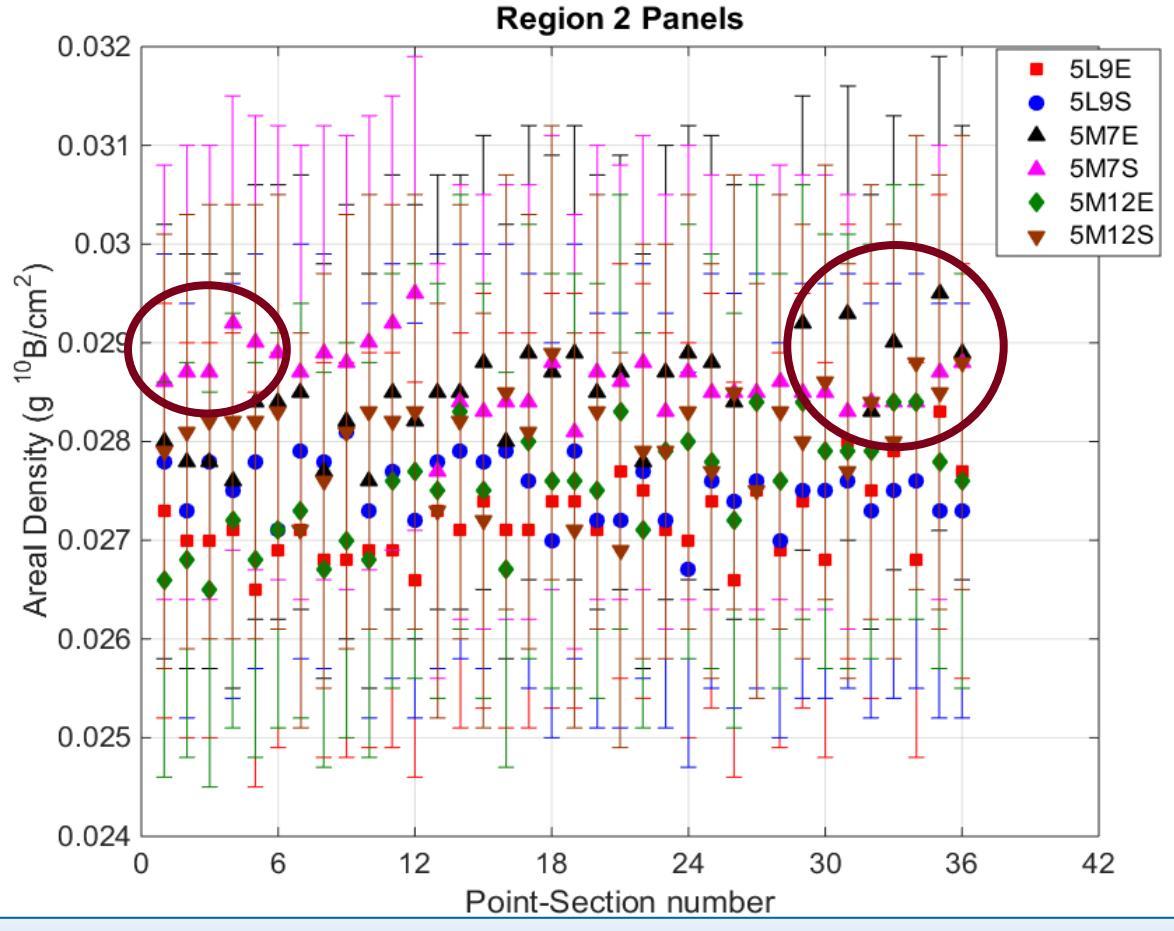
### **Variations in Areal Density for Zion Panels – Region 2**

#### **Variations in Areal Density**

- From panel to panel; for different points in the same panel; for different points within the same section
- No dependence in AD with axial height
